**BUILDING RESILIENCE IN THE FLOOD PRONE EDGE
OF LESSER HIMALAYAN CITY, CASE OF SRINAGAR
GARHWAL**

MASTERS OF LANDSCAPE ARCHITECTURE

**SCHOOL OF PLANNING AND ARCHITECTURE, BHOPAL
NEELBAD ROAD, BHOURI, BHOPAL (M.P.) – 462030**

MAY, 2017

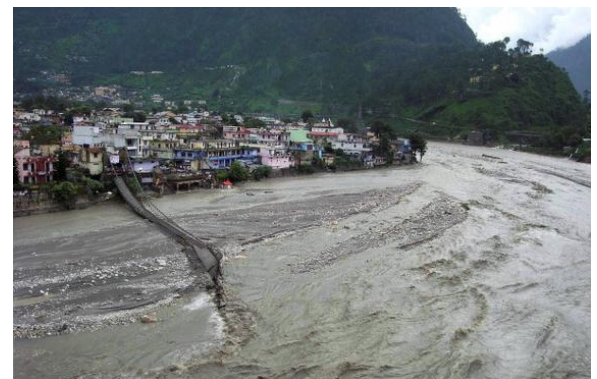
Inundation in flood plains encroached by settlements
Fig.1.6. Source: (thehindubusinessline July 15, 2013)

Fig.1.6. Inundation in flood plains encroached by settlements.

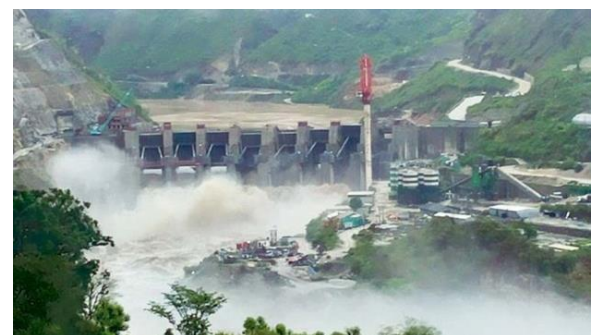
Dam in the upper reach of srinagar during floods
Fig.1.7. Source: (Daily mail June 18, 2013)

Fig.1.7. Dam in the upper reach of Srinagar during floods

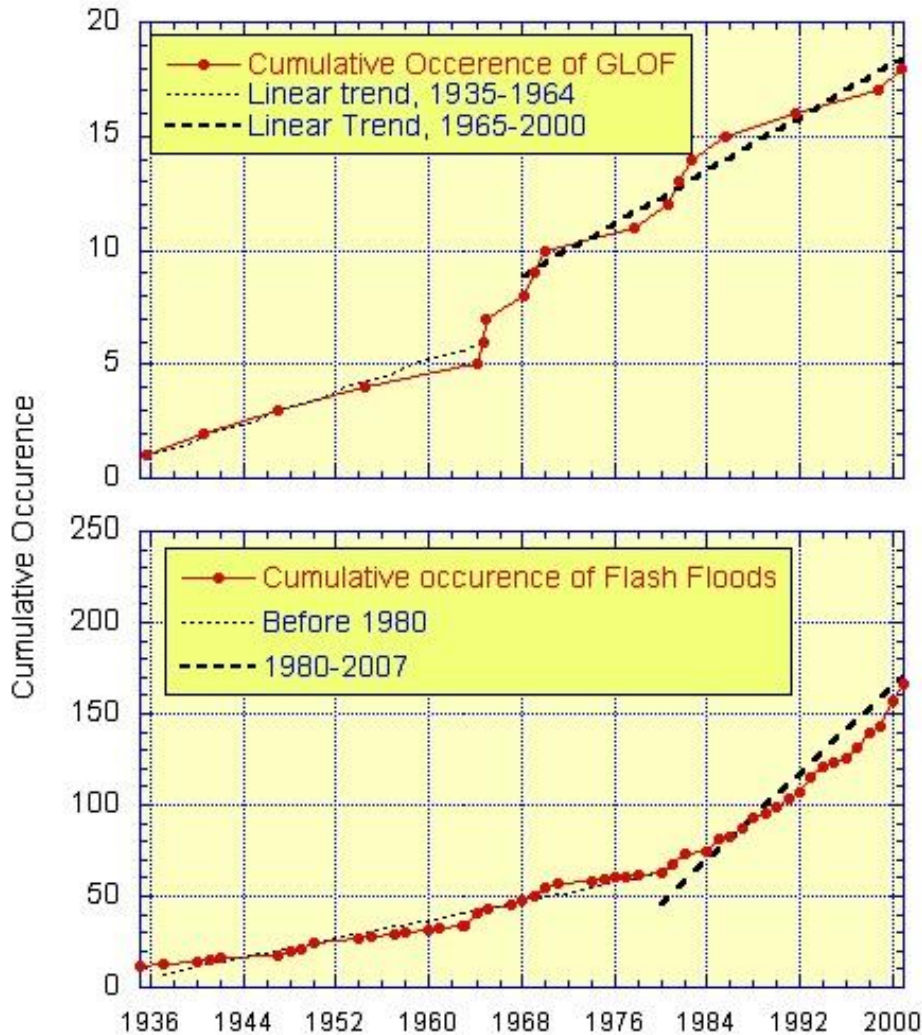
Fig.1.11. Rapidly increasing frequency of flash floods and GLOFs in Himalayas

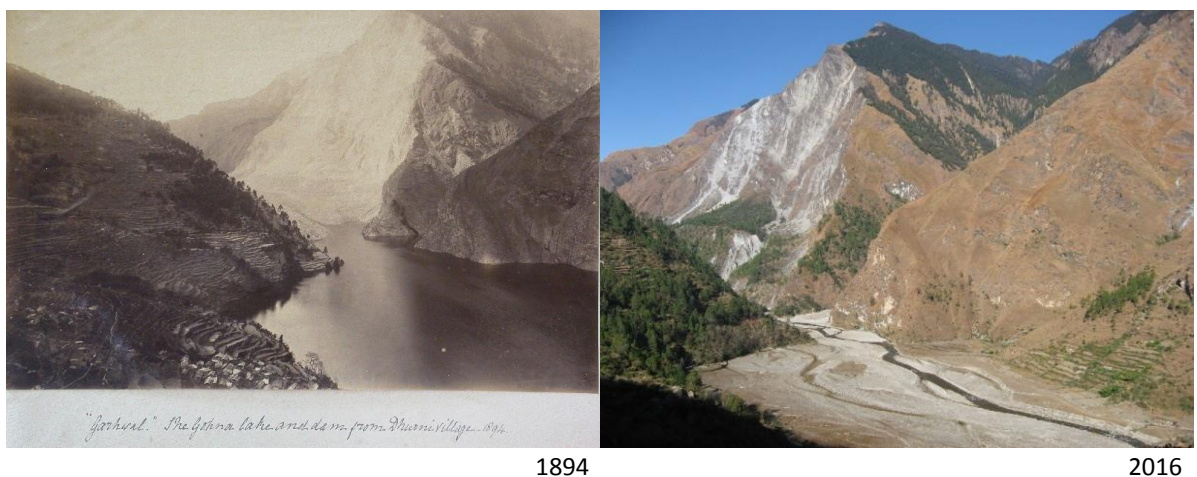
Fig.1.16. Gohna lake dam in 1894 and 2016

On September 1893, a tributary of the Alaknanda river called Birahi Ganga was blocked by ~5000 million tones of rock mass that rolled from 900 m high valley flank. The debris blocked the river forming a lake 270 m high, 3 km wide at the base and 600 m. (N. Rana, 2013)

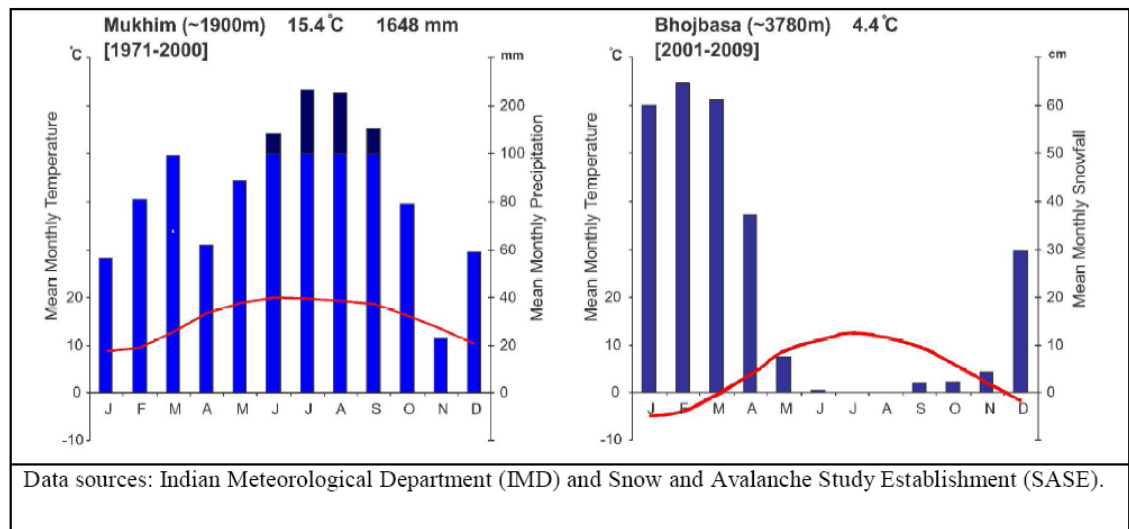
Fig.2.4. Climatic diagrams of mukhim and bhojbasa stations. SOURCE: Data sources: Indian Meteorological Department (IMD) and Snow and Avalanche Study Establishment (SASE).

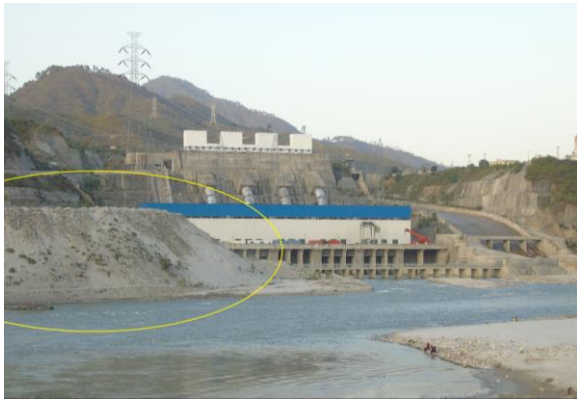
Fig.2.13. Huge muck dump next to SHEP
SOURCE: (SANDARP, 2015)

Fig.2.13. Huge muck dump next to SHEP

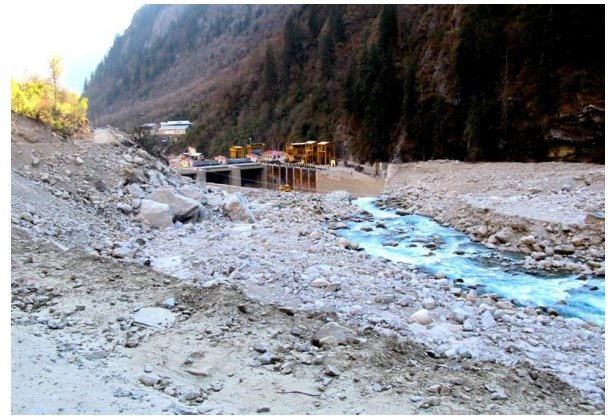
Fig.2.14. Dam destroyed in Vishnuprayag
SOURCE: (Circleofblue, 2014)

Fig.2.14. Dam destroyed in Vishnuprayag.

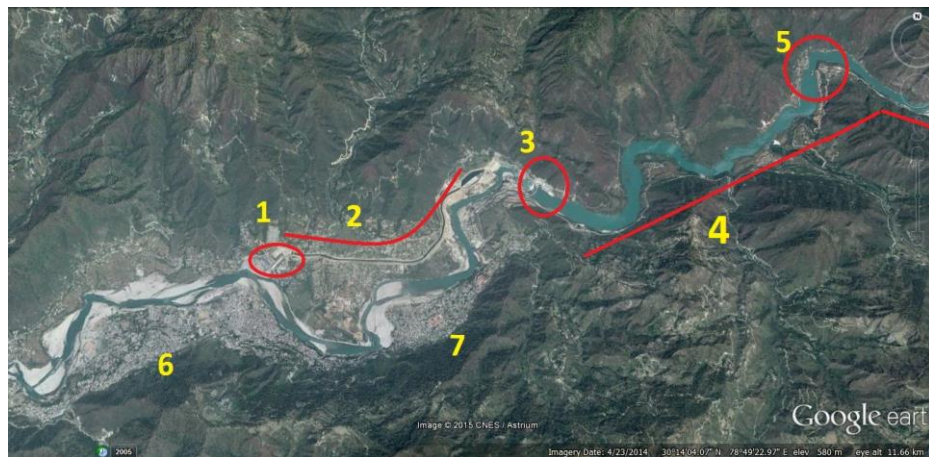
Fig.2.16. SHEP head, 2. Project canal, 3.Dam, 4.16 km long reservoir, 5. Dhari devi temple 6. Srinagar, 7. Srikot

Fig.2.16. SHEP head, Project canal, Dam, 16 km long reservoir, Dhari devi temple Srinagar and Srikot.

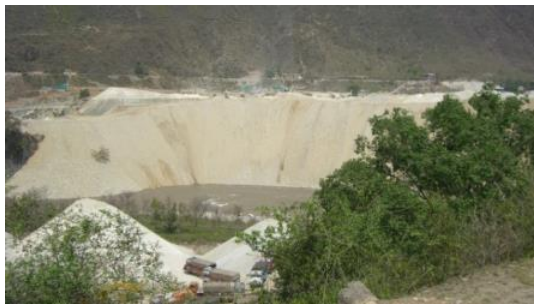
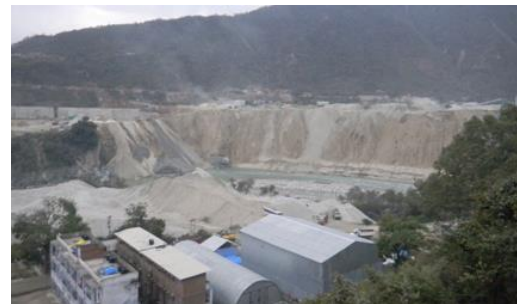
Fig.2.18. Overburden and muck dump along Alaknanda upstream of Srinagar.

Fig.2.18. Overburden and muck dump along Alaknanda upstream of Srinagar.

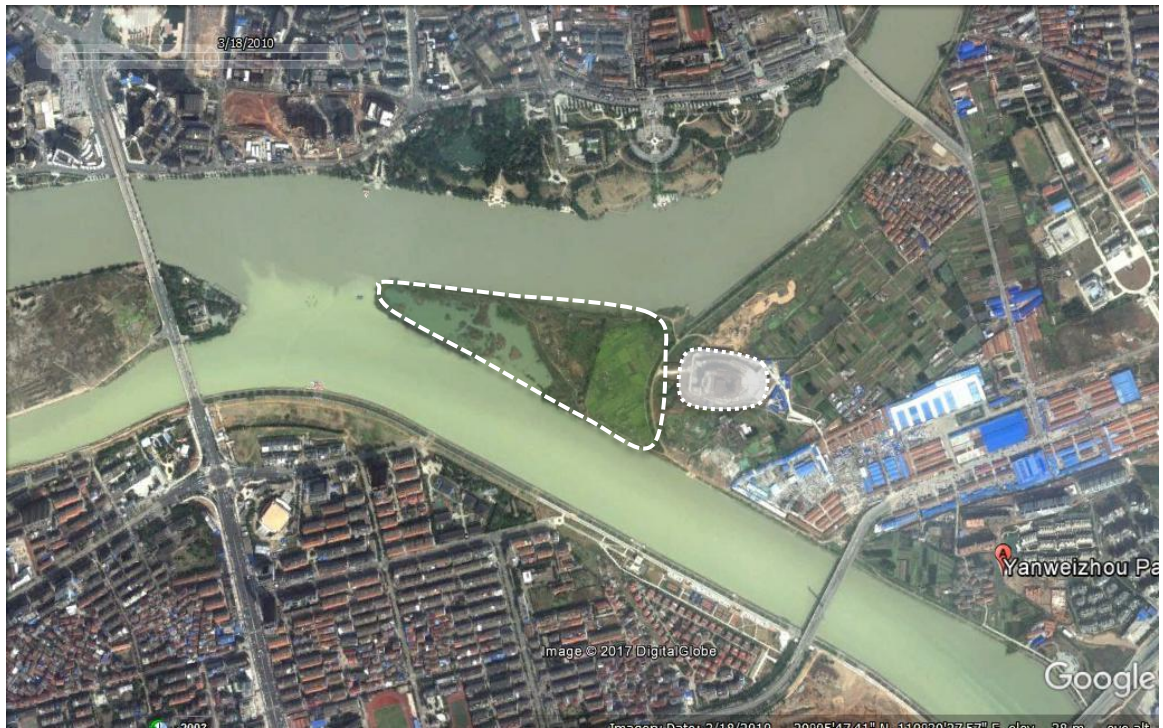
Riparian wetland
 Opera house

Fig.3.1. Satellite imagery showing remaining patch of riparian wetland with organic opera house of Yanweizhou, Jinhua, China.

Fig.3.1. Satellite imagery showing remaining patch of riparian wetland with organic opera house of Yanweizhou, Jinhua, China.

- How can the **remaining patch of riparian habitat be preserved** (Figure 3.1) while providing amenities to the residents of the dense urban center.
- What **approach to flood control should be used** .
- How can the existing organically shaped building be integrated into the surrounding environment **to create a cohesive landscape** that provides a unique experience for visitors?
- Finally, and most importantly, how can the separated city districts be connected to the natural riparian landscape **to strengthen the community and cultural identity** of the city of Jinhua (Figure 3.2)?

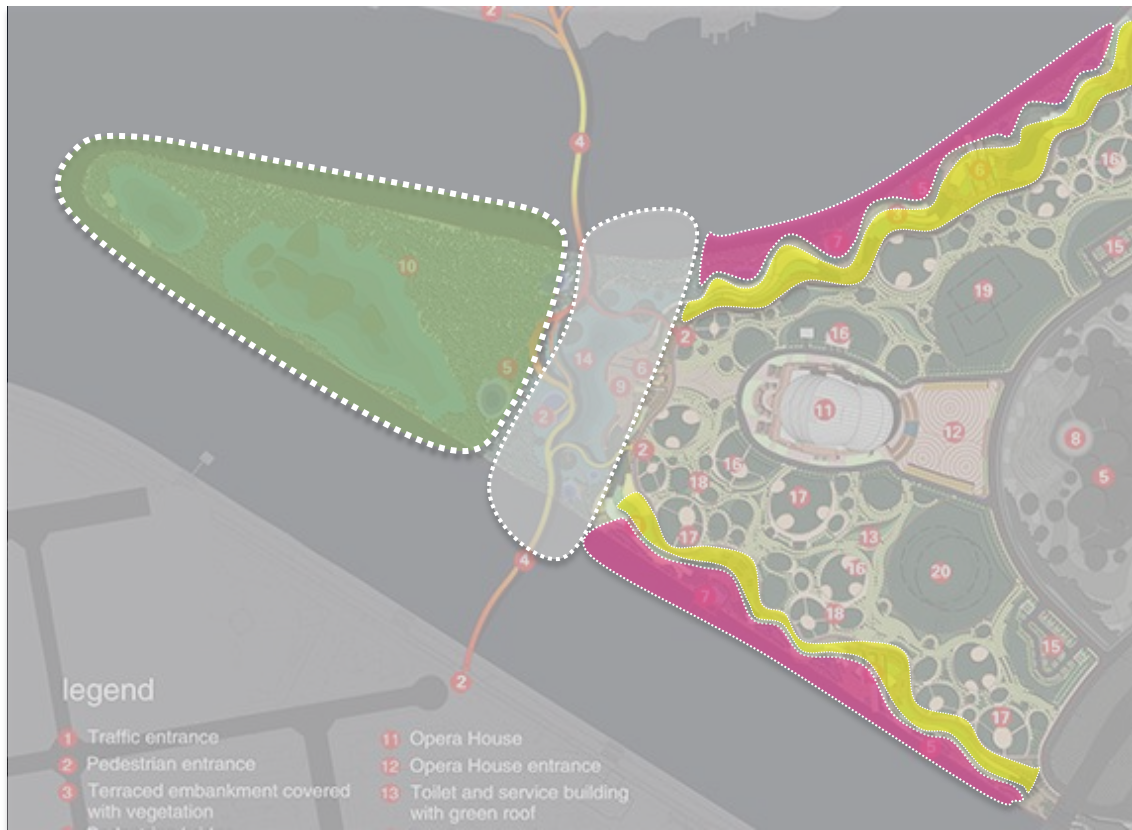
Fig.3.4. The existing wetland was preserved with no intervention and existing riparian sand quarries With minimum intervention as these are part of river ecosystem and needs to be free of human intervention

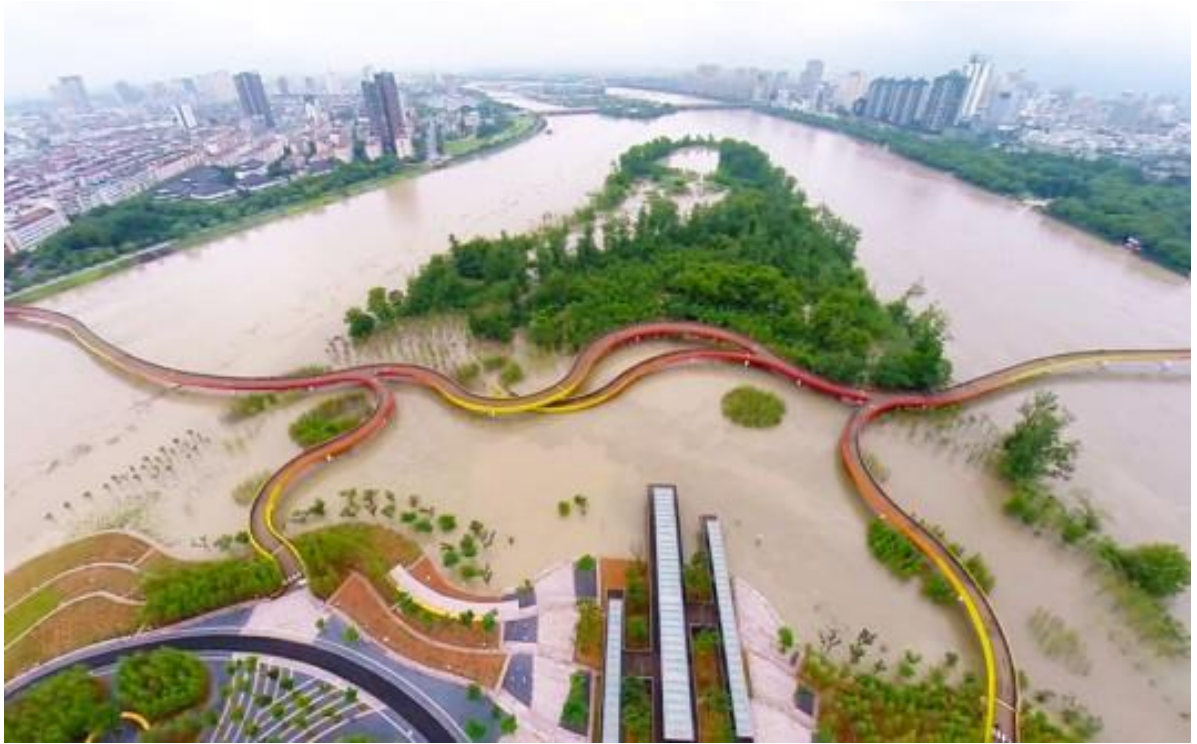
Fig.3.8. An aerial view of the park during the monsoon season showing a 20-year flood and testifying to the flood resilient design. Note the uninterrupted connection of the city through the bridge (the view is toward the west, photo: May, 2014).

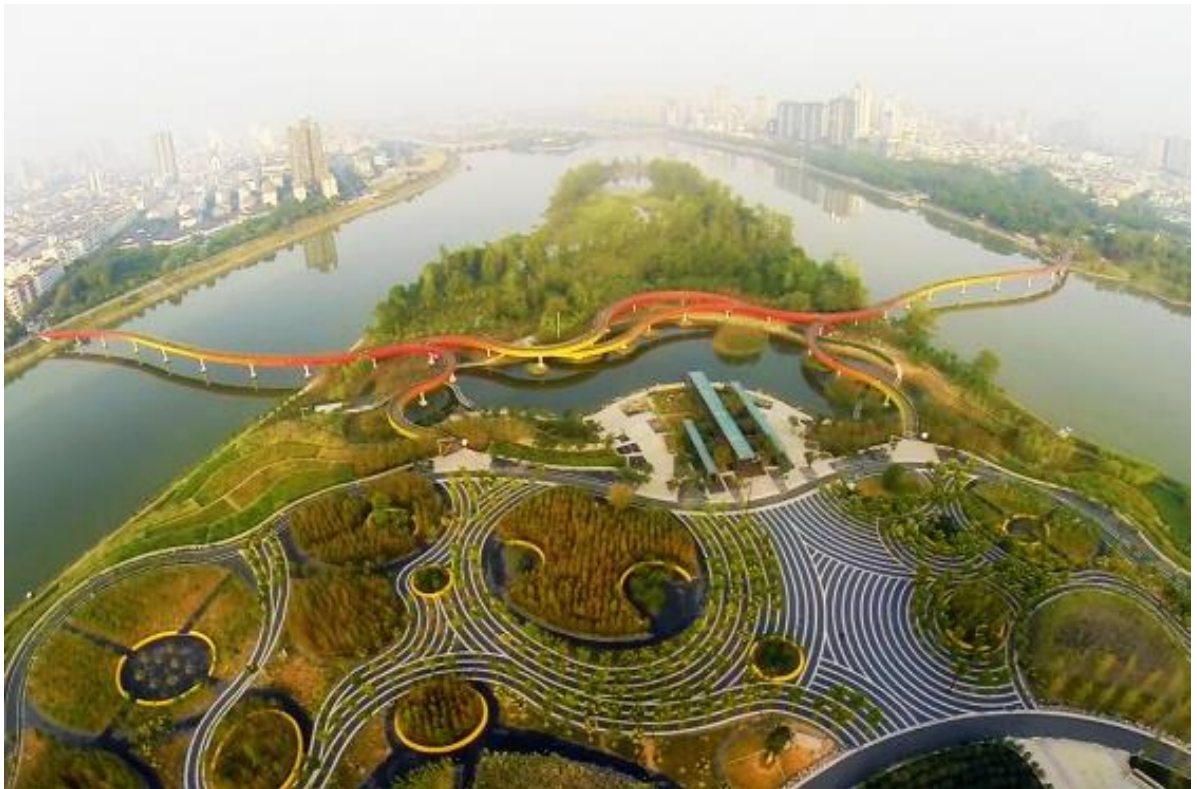
Fig.3.9. An aerial view of the park during the dry season, note the lush tall grasses covering the terraces on the embankment. The terraces are enriched by silt deposited during the flood season (view is toward the west, photo: November, 2014).

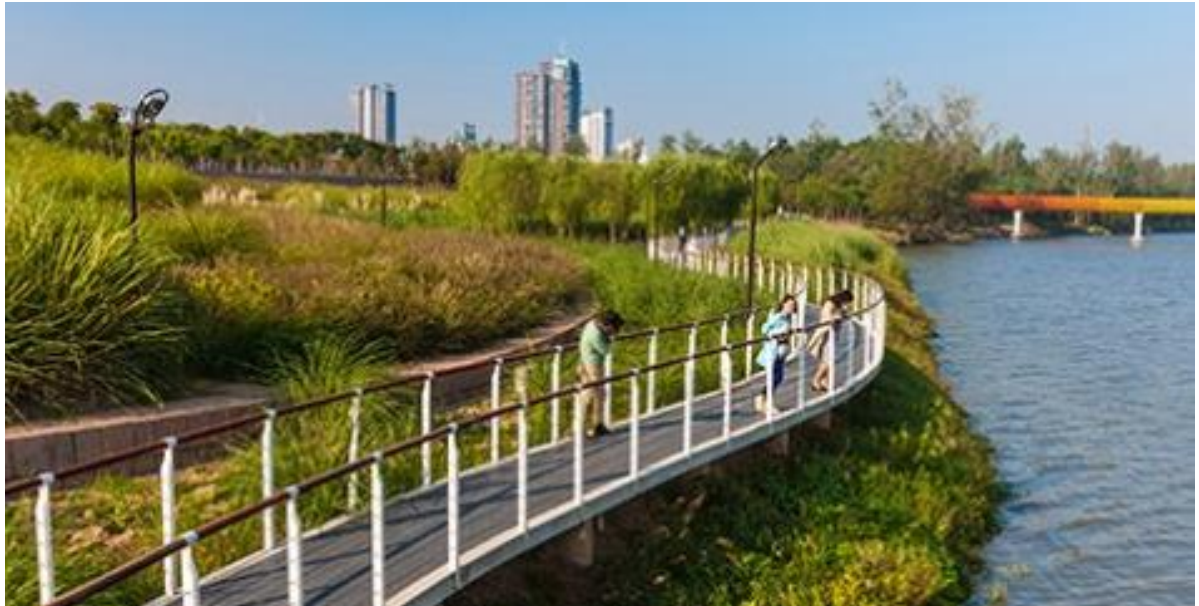
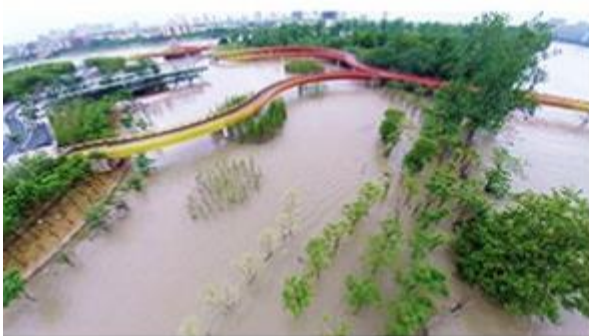
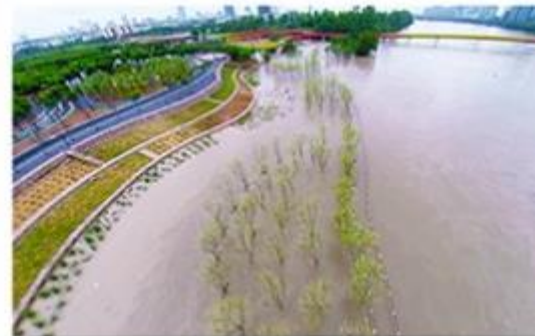
Dry season

Flood season

Fig.3.10. The flood-adapted boardwalk integrates the path system with the terraces. This path affords visitors an intimate naturalistic experience over the riparian vegetation. The elevated boardwalk is just above the five-year flood level (view is toward the southwest).

Floodable pedestrian paths (Fig.3.10) and pavilions are integrated with the planting terraces (Fig.3.11), which will be closed to the public during the short period of flooding.

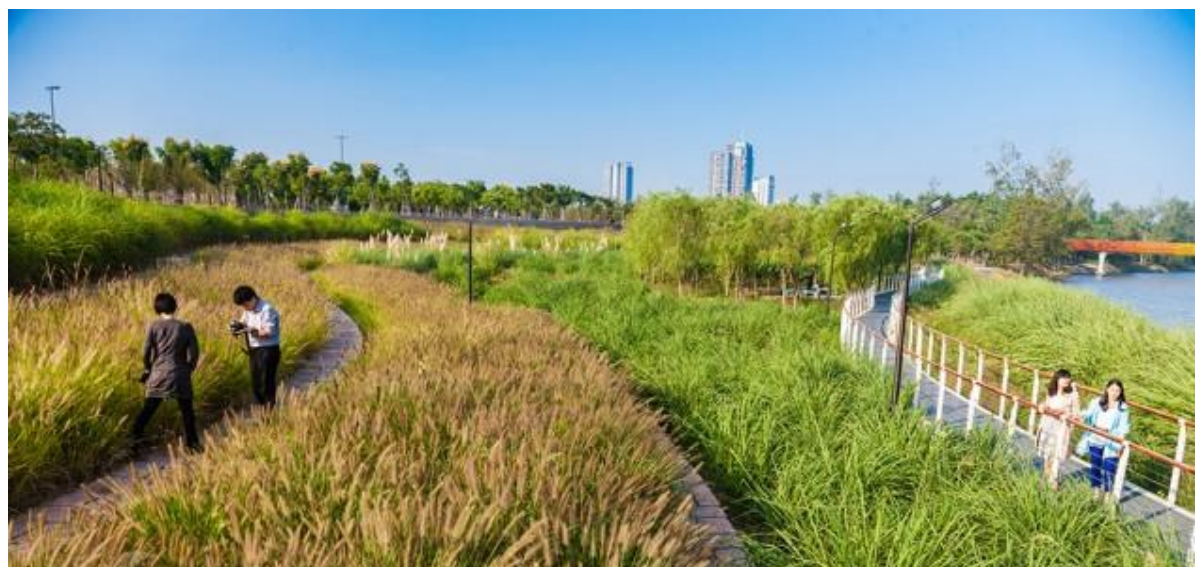
Fig.3.11. The beautiful terraced embankment was built by removing the concrete floodwall and through a cut-and-fill strategy that balances the earthwork on-site. The terraces create a flood resilient zone that allows people to enjoy the lush tall grasses adaptive to the seasonal floods.

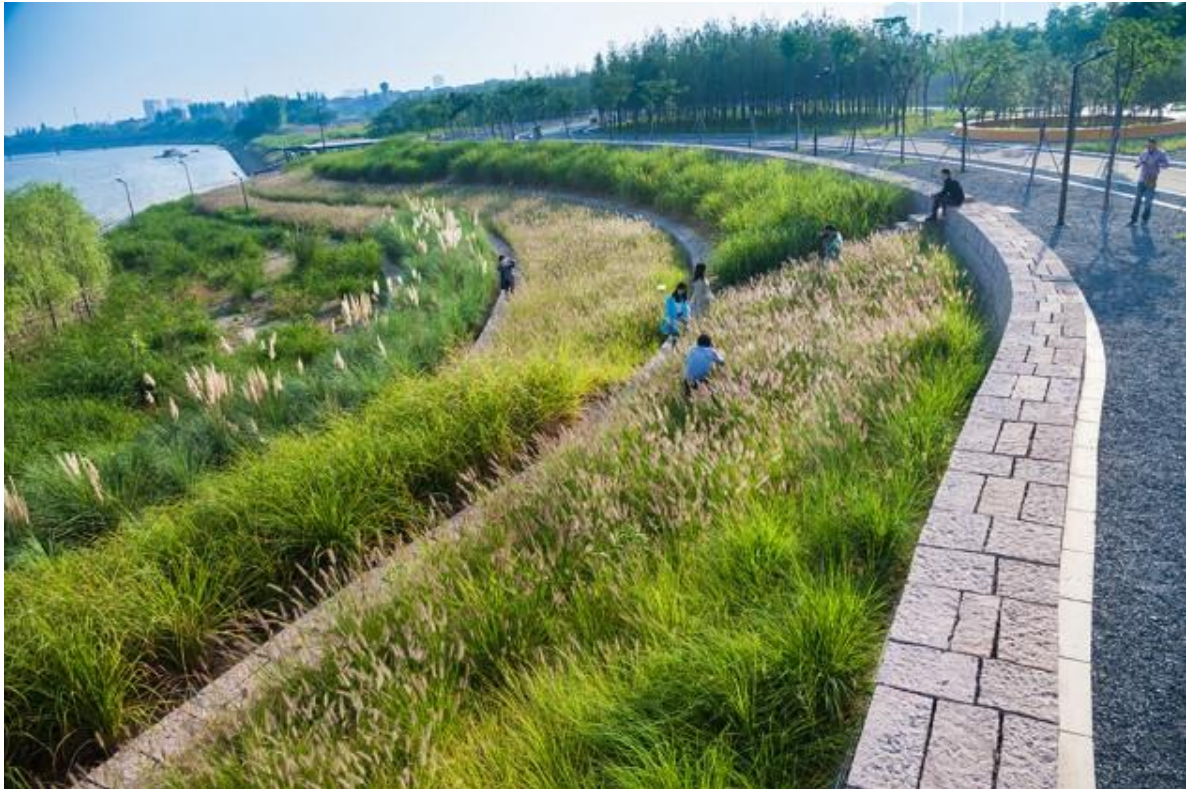
Fig..3.12. The terraced embankment in flood resilient zone is accessible through stairs and paths along the top of terrace walls for emersion within the varied texture, color and movement of the lovely grass panels (view is toward the east).

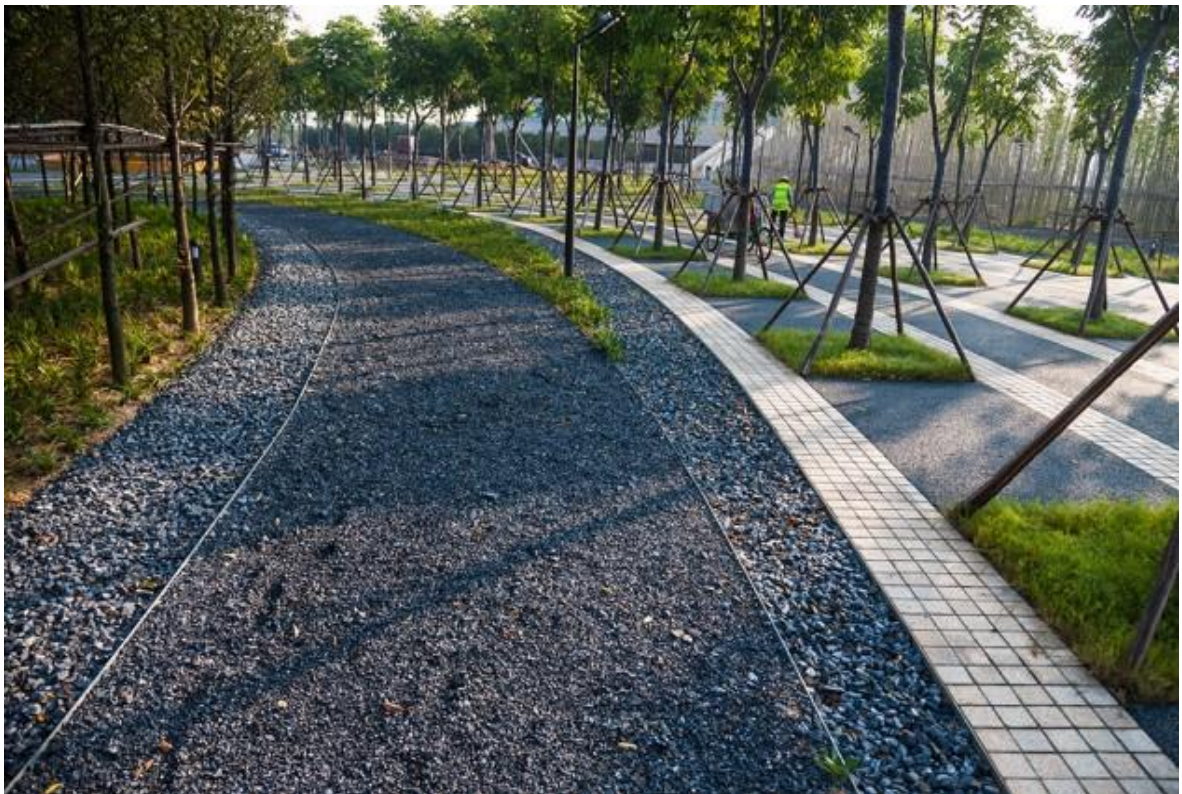
Fig..3.13. Water resilient material used in paving.

the inland area is entirely **permeable** in order to create a water resilient landscape through the extensive use of gravel that is reused material from the site (Fig.3.13). The gravel is used for the pedestrian areas, the **circular bio-swales** are integrated with tree planters (Fig.3.17), and **permeable concrete pavement** is used for vehicular access routes and parking lots. The inner pond on the inland is designed to encourage river water to infiltrate through gravel layers (Fig.3.19). This mechanically and biologically improves the water quality to make the water swimmable.

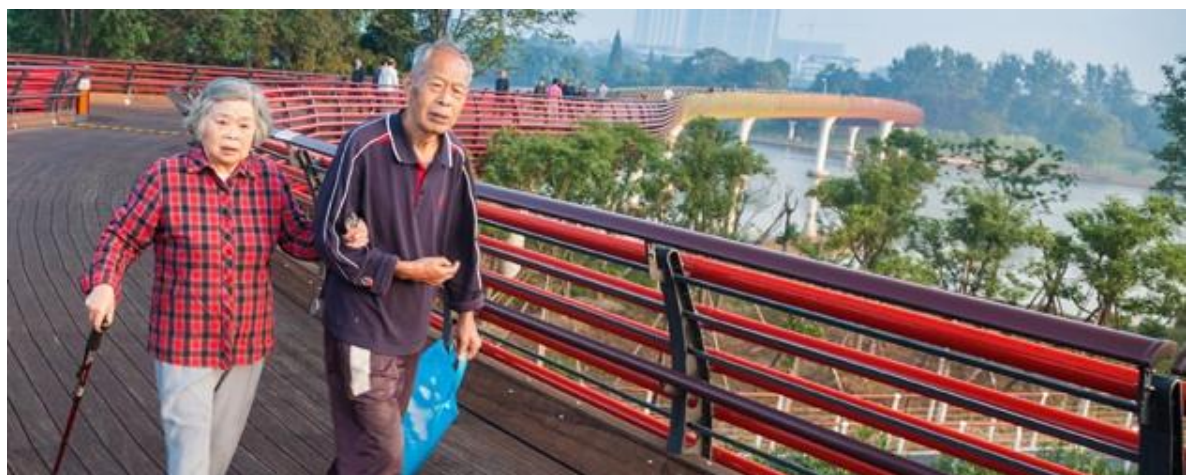
Fig.3.15. The Bayong Qiao bridge flies above the former sand quarry and connects the city with nature. The former sand quarry has been transformed into a pleasant park that allows people to have intimate contact with the remnant patch of the wetland forest.

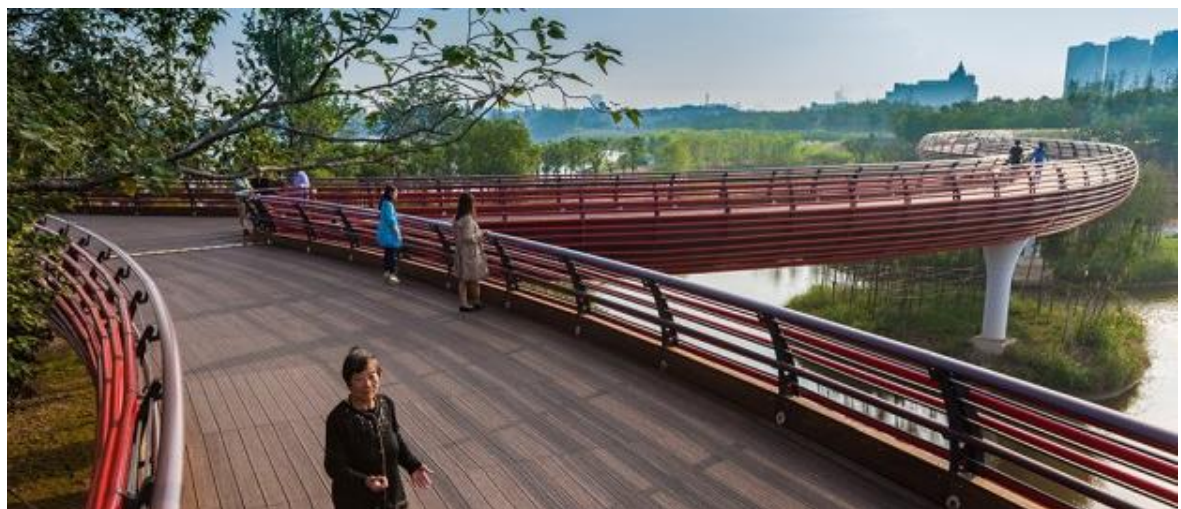
Fig.3.16. With multiple ramps aligned to the flow of people, the Bayong Qiao bridge is more than a physical link. It is a social connection that helps to build the community by creating a gathering space for families and residents who walk, jog and chat together on the bridge.

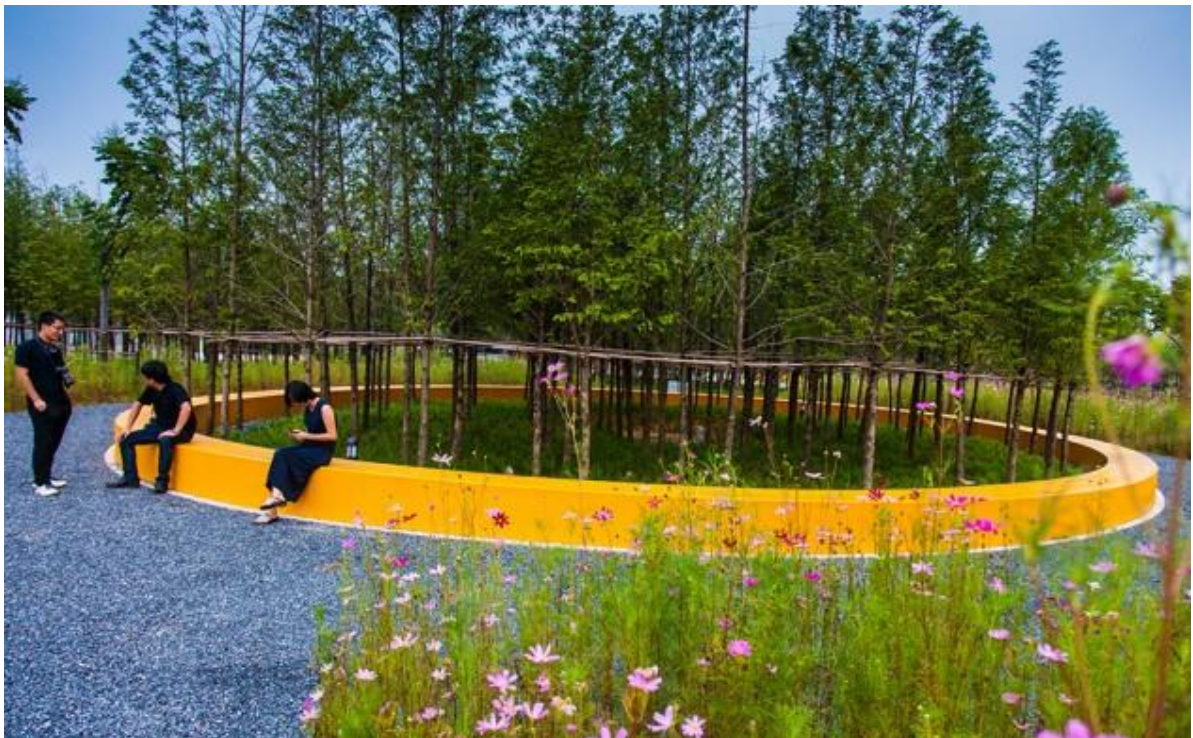
Fig.3.17. Circular bioswale. The surfaces include gravel surface bioswales for planting, and permeable concrete for automobile use.

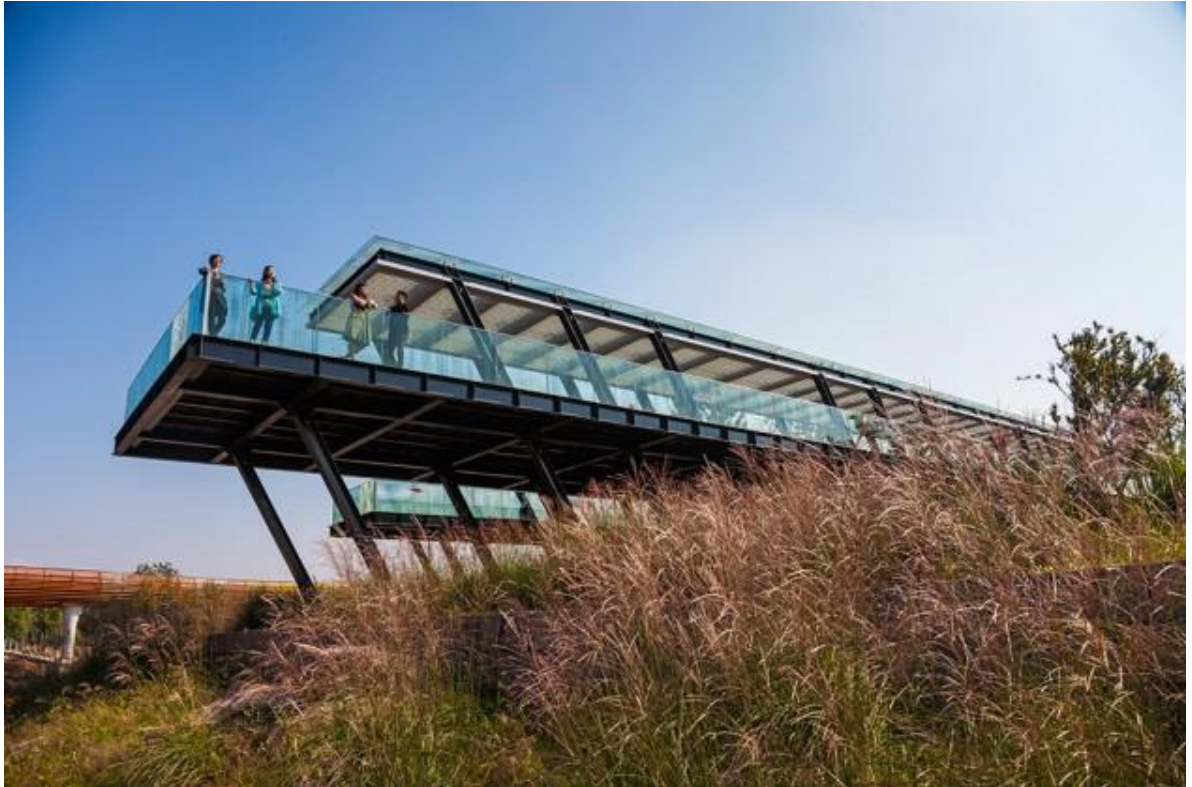
Fig.3.18. This pavilion provides a dramatic viewpoint as it extends above the 200-year flood level. The pavilion features a detailed view of the pond water feature and expansive views of the river, the city and the Bayong Qiao bridge.

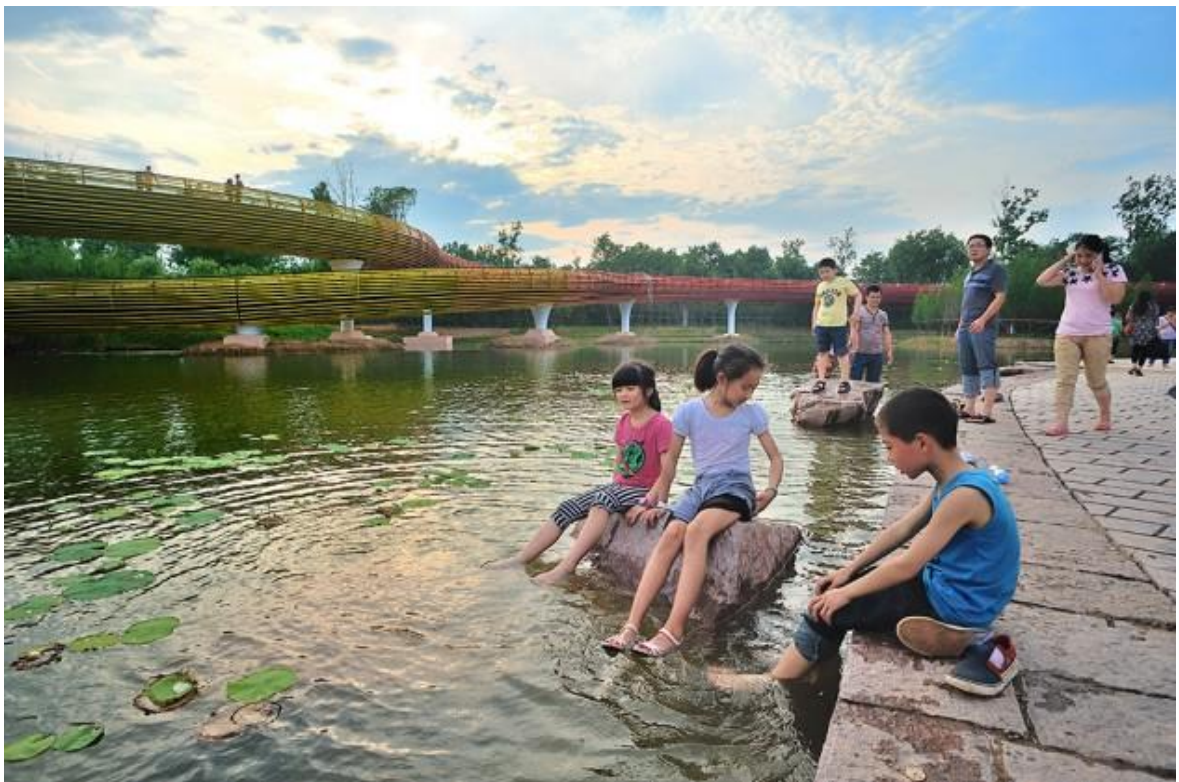
Fig.3.19. The inner pond on the inland is designed to allow water to infiltrate from the river through the gravel layers that make the otherwise dirty river water swimmable (kids playing in the pond, summer, 2014).

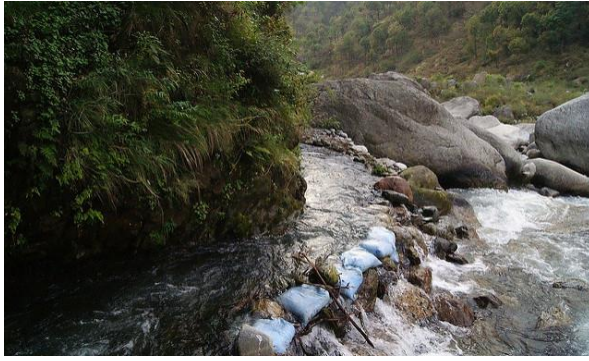
Fig.3.20. The kuhl (left) is diverted from the glacier-fed stream (right). SOURCE: (indiawaterportal August 2014)

Kuls was constructed across a ravine to divert the waters of natural flowing streams (khud) through a canal to the fields. About 20 ha could be irrigated by a community kuhl. The water would flow from field to field and surplus water would drain back to the khud. The kohli or water tender distributed and managed the water. The contour channels called **guhls** were used extensively. Streams were dammed by temporary barriers to divert water into these channels.

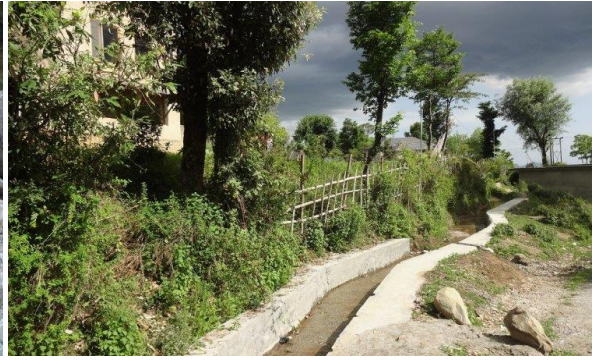
Fig.3.21. Kuhls carry glacial melt to fields for irrigation. SOURCE: (indiawaterportal August 2014)

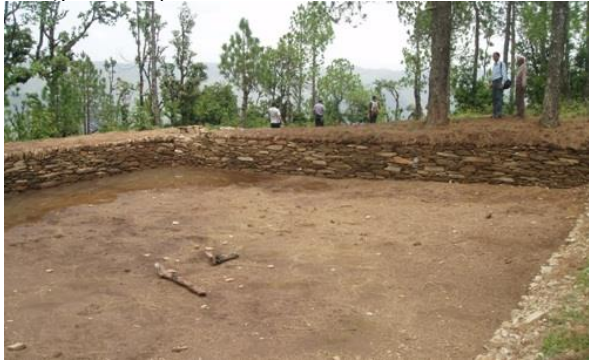
Fig.3.22. Dry stone check dam, Silalekh SOURCE: (www.gramya.in August, 2013)

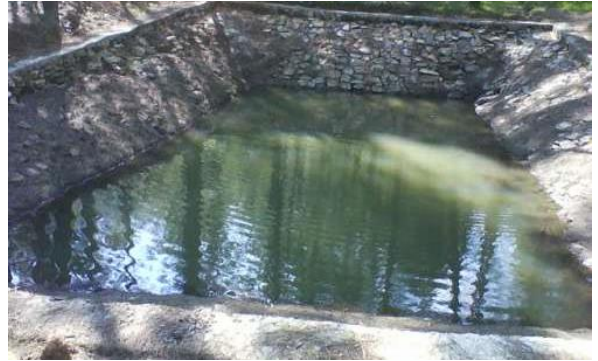
Fig.3.23. Stone pitched pond, SOURCE: (www.gramya.in August, 2013)

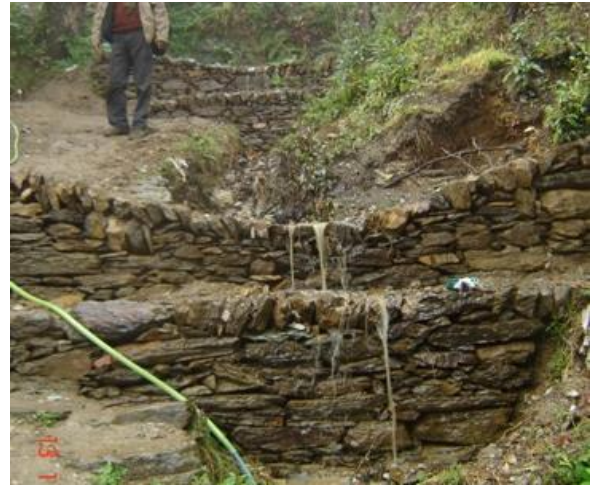
Fig.3.25. Dry stone check dams, SOURCE: (www.gramya.in August, 2013)

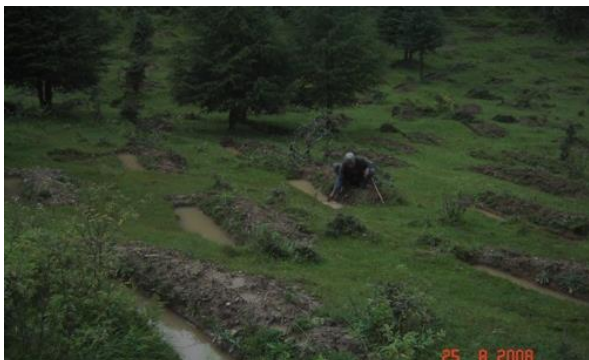
Fig.3.26. Staggered contour trenches. SOURCE: (www.gramya.in August, 2013)

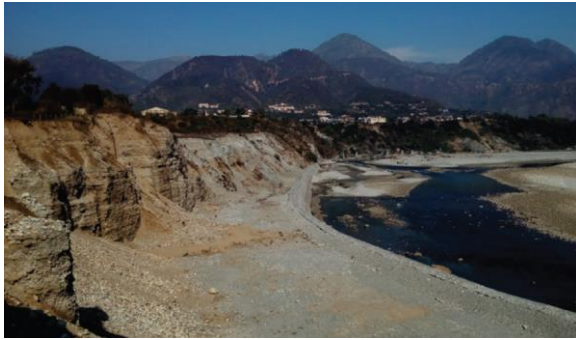
A. Sedimentation at the Srikot area. New flood terrace can be seen, some of the area was inundated during 2013 flood, this sits on the lowest of flood plain.

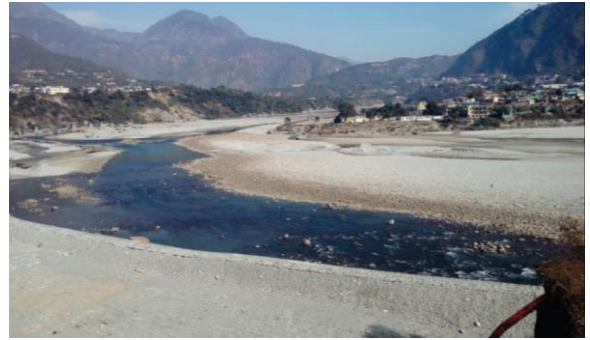
B. Toe erosion at the bank. This was highly directed towards the muck disposal at the bank which further increased the sedimentation yield in the lower plain

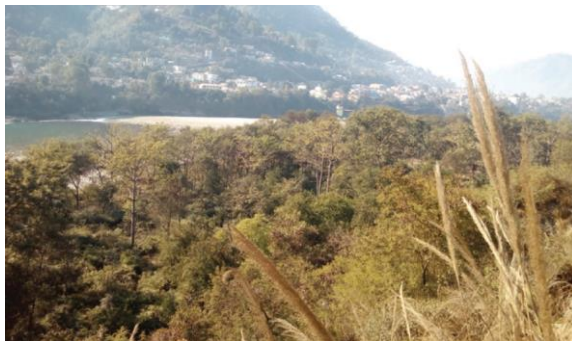
C. Typical riparian buffer which include the plant community of bombex Ceiba, delbergia Sisoo, Albizia Stipulata, Dendrocalamus Strictus, Pennisetum purpureum. is under pressure because of Illegal forest cutting which further threaten the buffer.

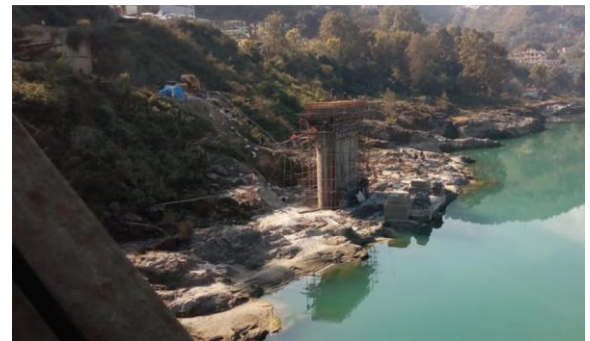
Exposed bedrock turns the river in other direction ,generally low density settlements are present in these areas

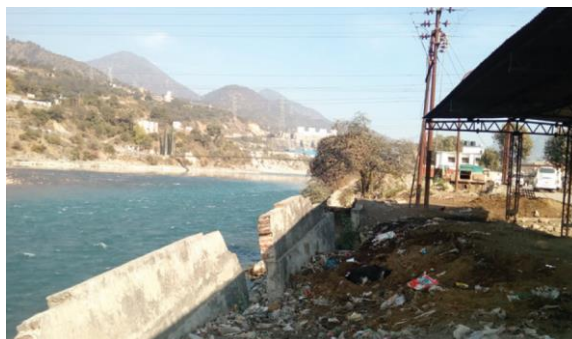
D. Concrete retaining wall creates ecological problems between water and land. In a long run it is failure as dead load increases with base flow. Important public transport route goes in this zone with one bus stand.

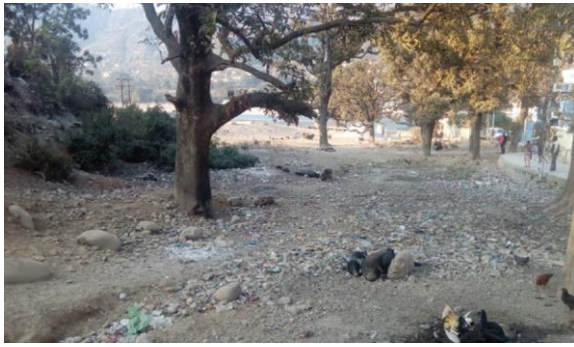
F. This is towards the way to temple, which is susceptible to erosion.

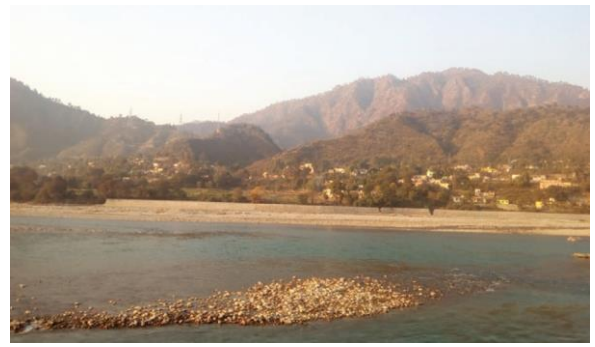
G. Flood water attacking the crop field in the lower portion of village.

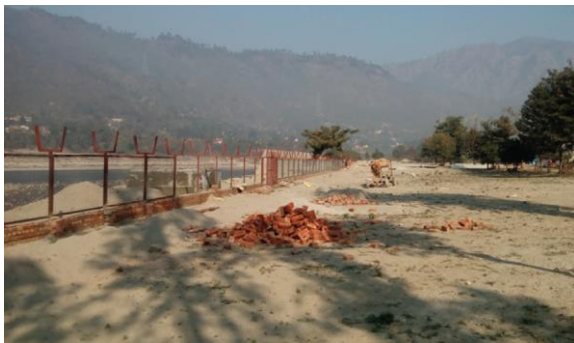
H. Sedimentation yield was highest in this portion, created meters of silt deposition in this area. Retaining wall of concrete has been constructed sometimes ranging up to 7 m from base level.

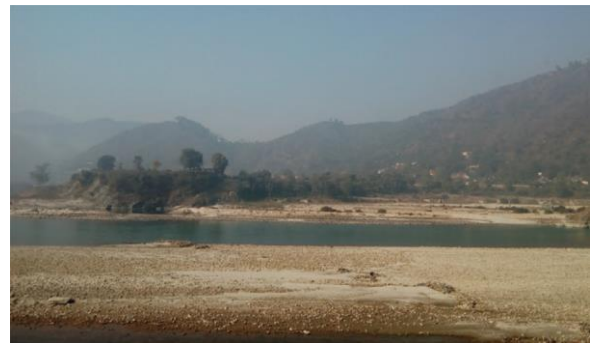
I. Srinagar phyllite is exposed at the mid section of the river which further extends upwards, diverting the course of river and further attacking SSB area, nit campus shown in image H.

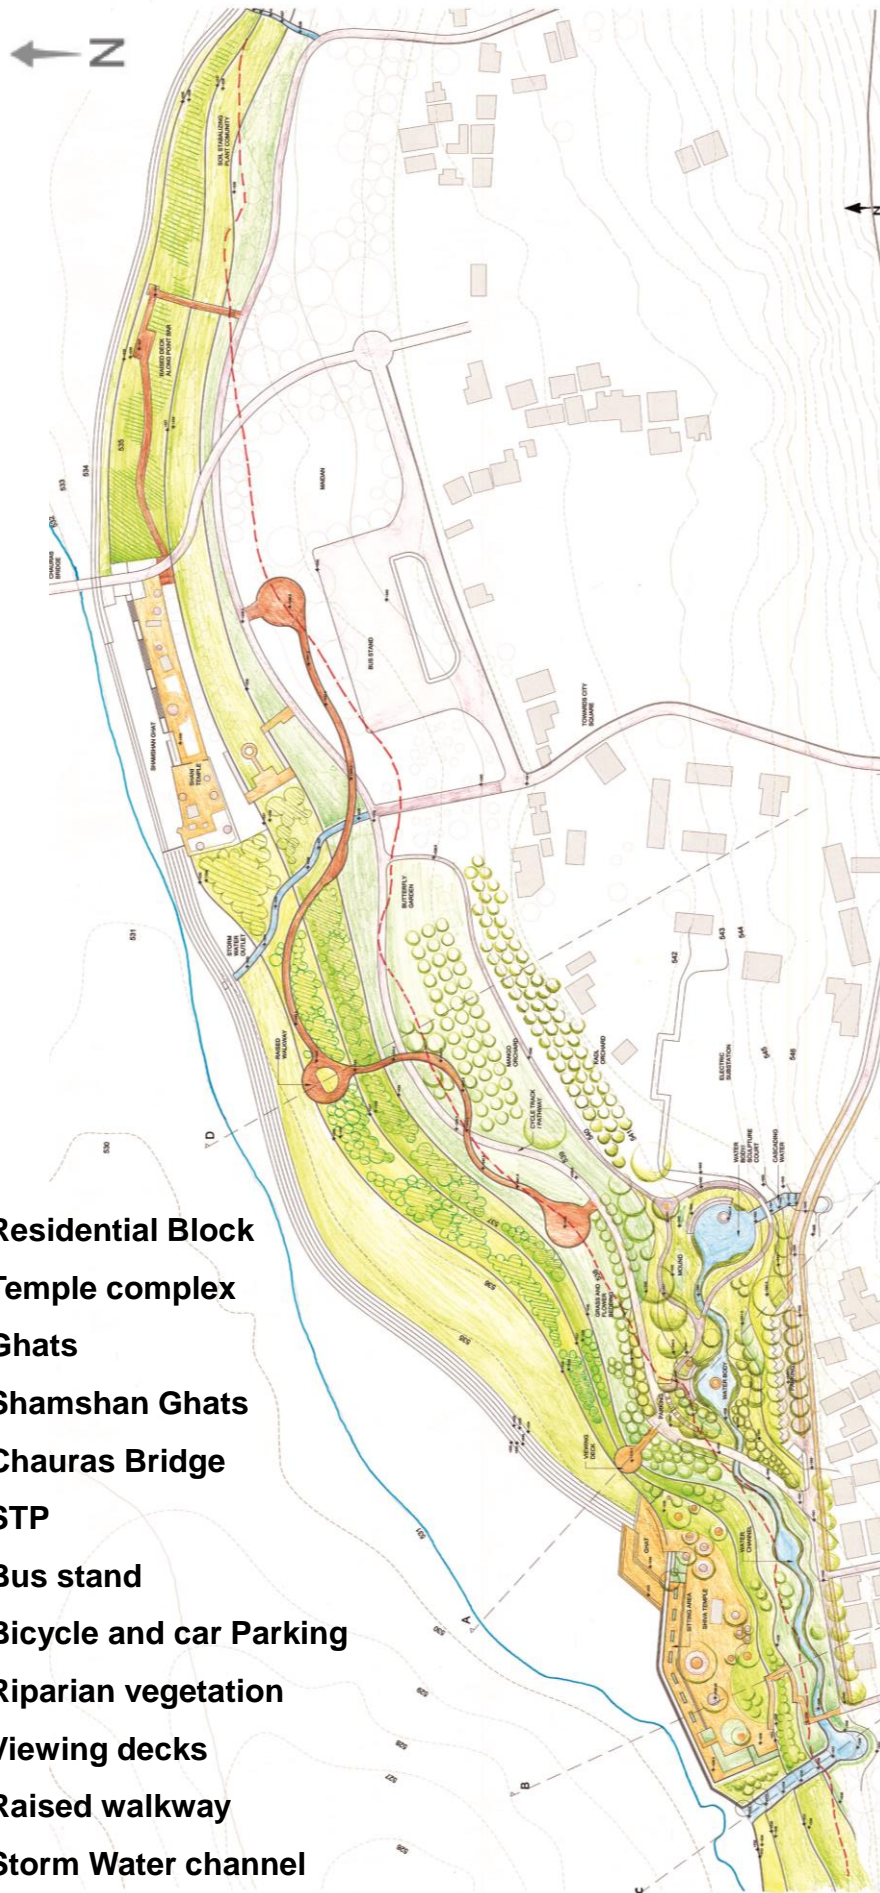
Fig.8.1. Design Intervention along the edge.
