**BUILDING RESILIENCE IN THE FLOOD PRONE EDGE
OF LESSER HIMALAYAN CITY, CASE OF SRINAGAR
GARHWAL**

MASTERS OF LANDSCAPE ARCHITECTURE

**SCHOOL OF PLANNING AND ARCHITECTURE, BHOPAL
NEELBAD ROAD, BHOURI, BHOPAL (M.P.) – 462030**

MAY, 2017

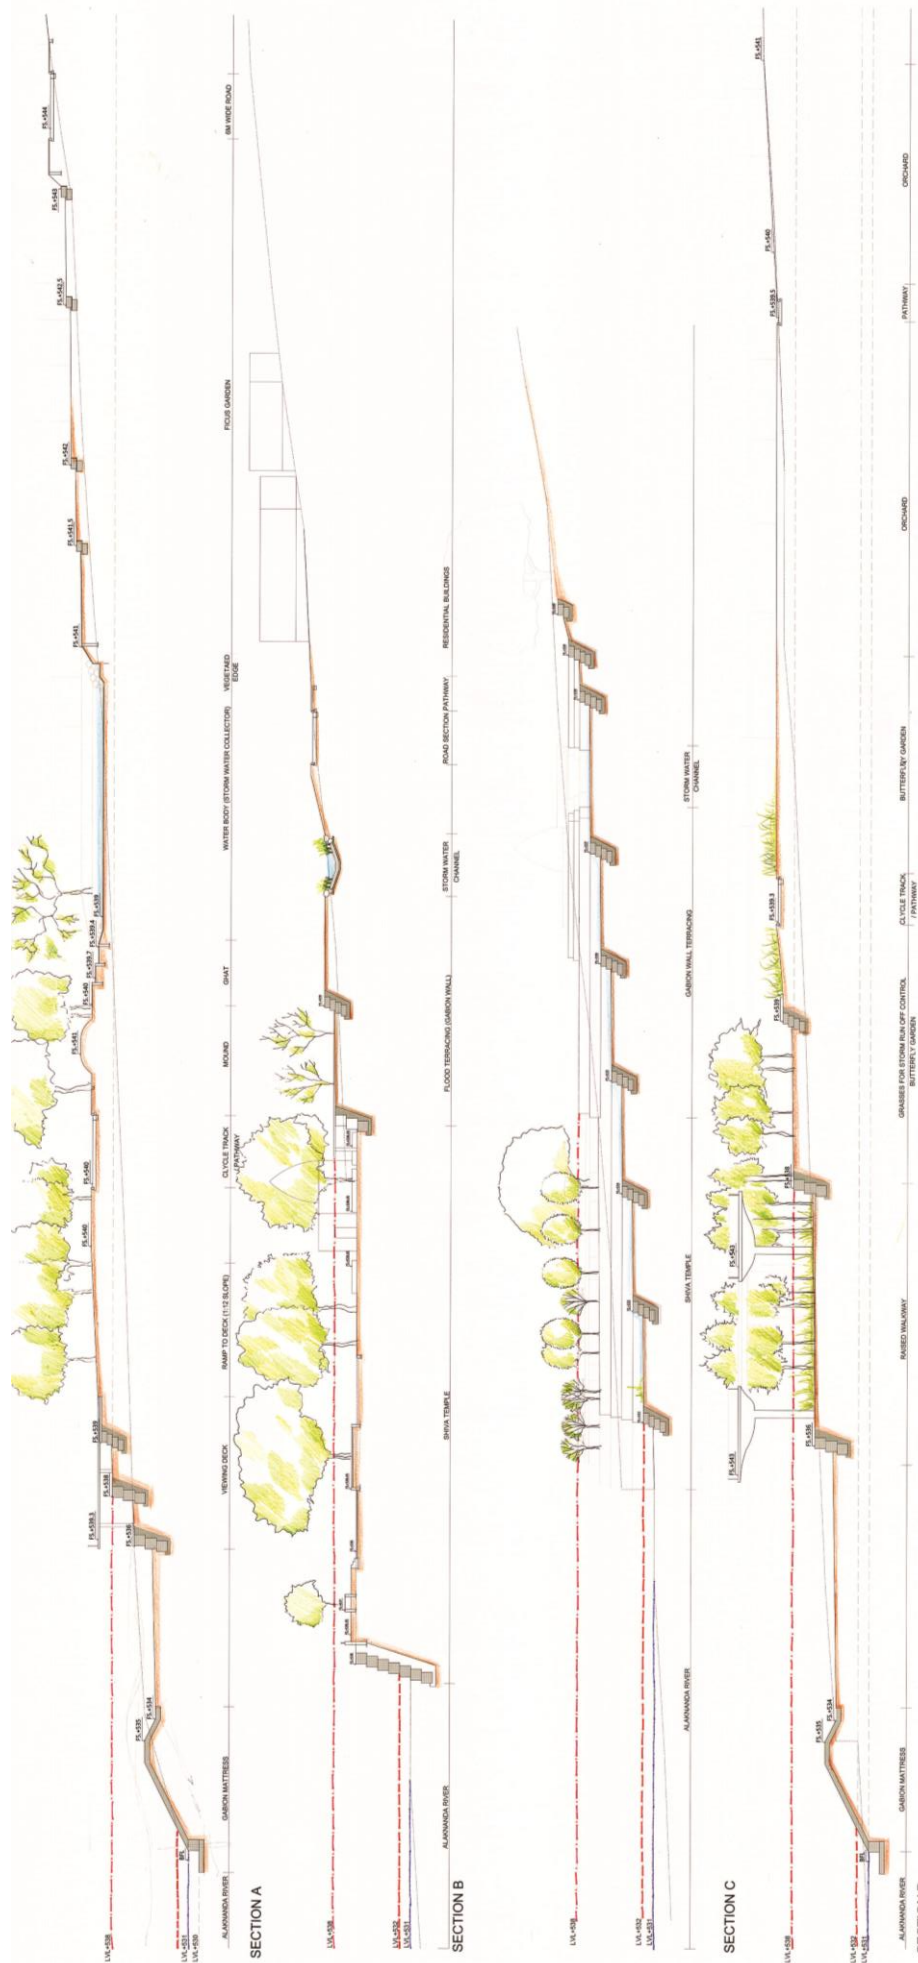
Fig. 8.2. Section showing Urban park in response to flood level

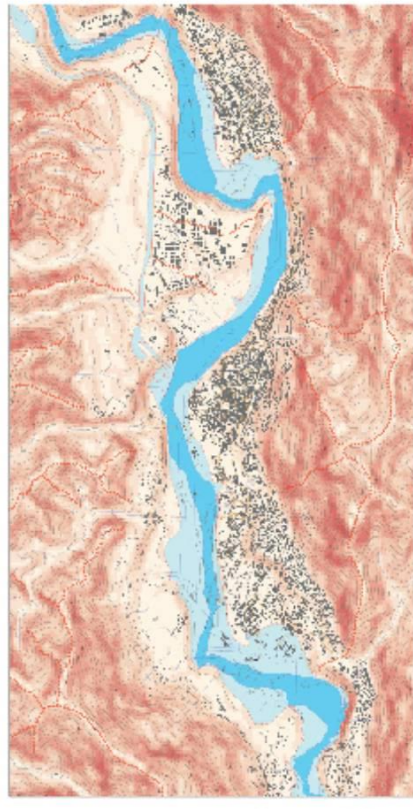
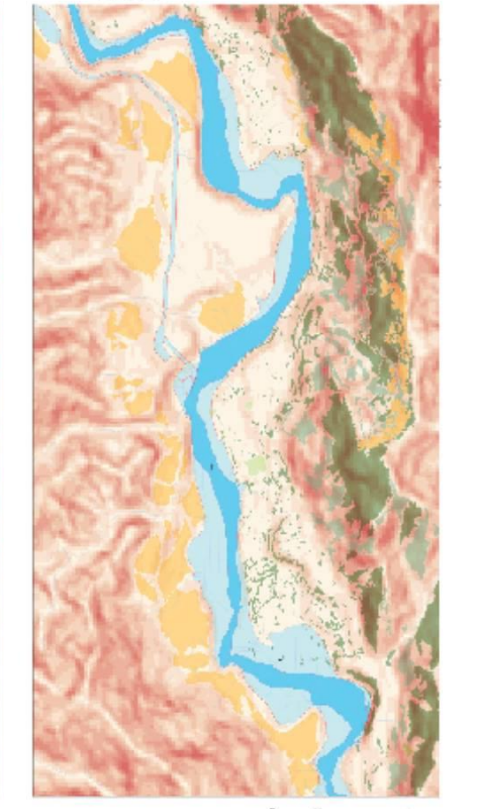
HYDROLOGY:
 This section discusses the hydrological characteristics of the study area, including the location and flow of rivers and streams. It highlights the flood-prone areas and the impact of urbanization on the hydrological cycle.

SLOPE ANALYSIS:
 This section describes the methodology and results of the slope analysis. It explains how the slope of the terrain affects the distribution of vegetation and the risk of landslides.
