# ENHANCEMENT OF A RIVER ISLAND IN PUNE

MASTERS OF LANDSCAPE ARCHITECTURE

**MANAVRAAJ YADAV**

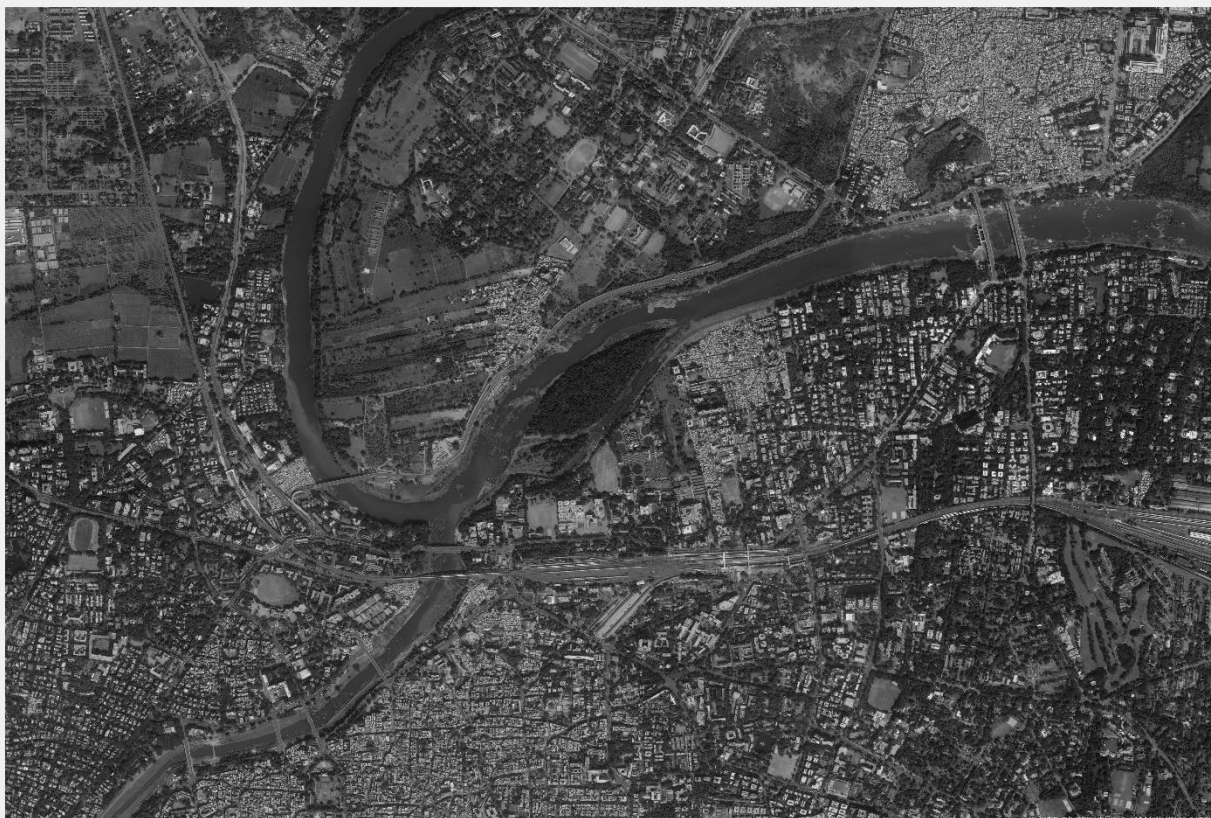
Fig 7: An overview of the island with respect to the surrounding urban fabric.

are dominated by Institutional complexes. The northern end is reserved for agricultural purposes as per the 1978 PMC development plan. As per the Draft Development Plan for

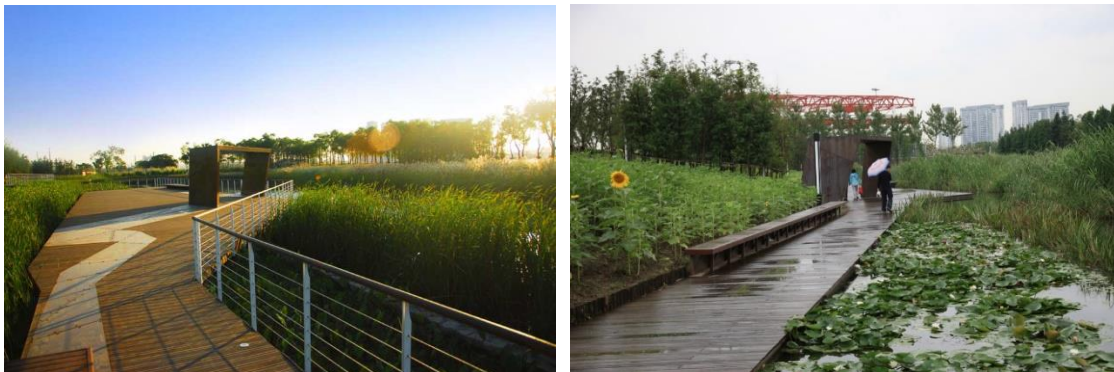
Fig 10: An overview of project with respect to the circulation and edge interaction.

The wetland also acts as a flood protection buffer between the 20 and 1000 year flood control levees. The existing concrete floodwall was replaced by a more habitat friendly

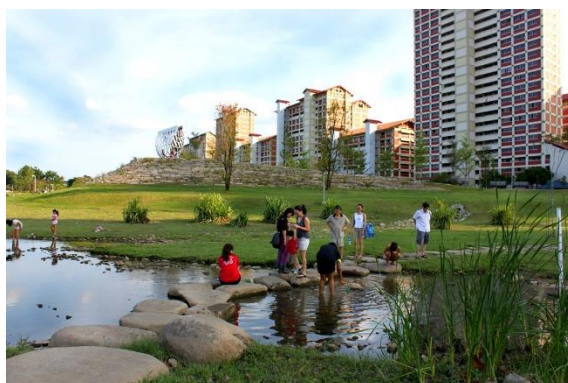
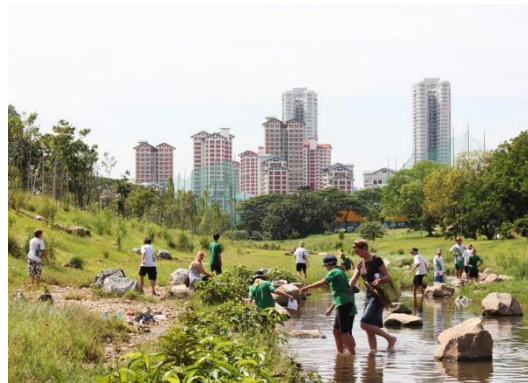
Fig 12: Change in cross-section cites the importance of interaction with water.

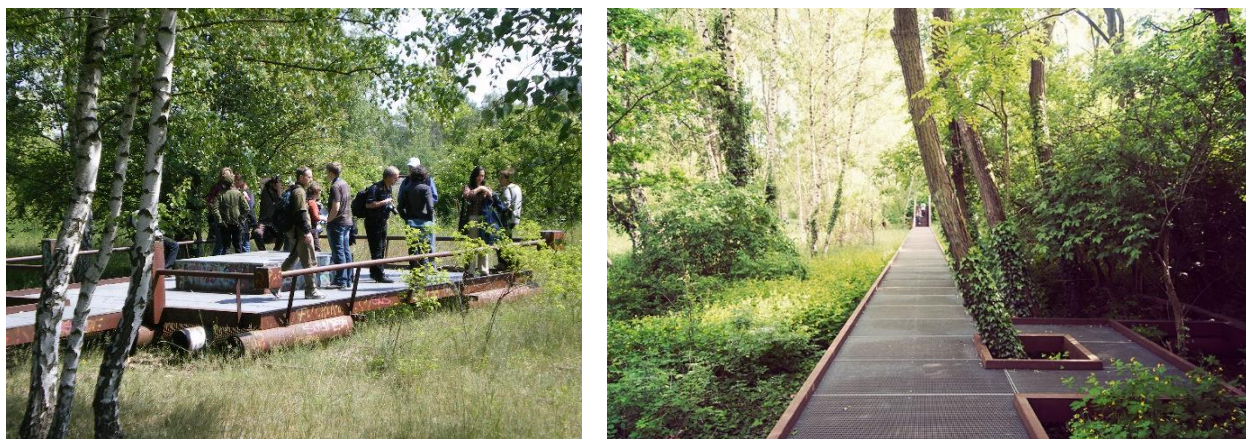
The Südgelände Nature Park is characterized by an intriguing combination of nature, railway artifacts, and art. Visitors are led along walkways and paths that follow the course of the former tracks. An artists' group ODIIOUS was responsible for the creative construction of the walkway. Art objects placed at special accents and enhance the grounds.

Fig 14: Boardwalks and look-outs make the site less invasive from the human visitors.

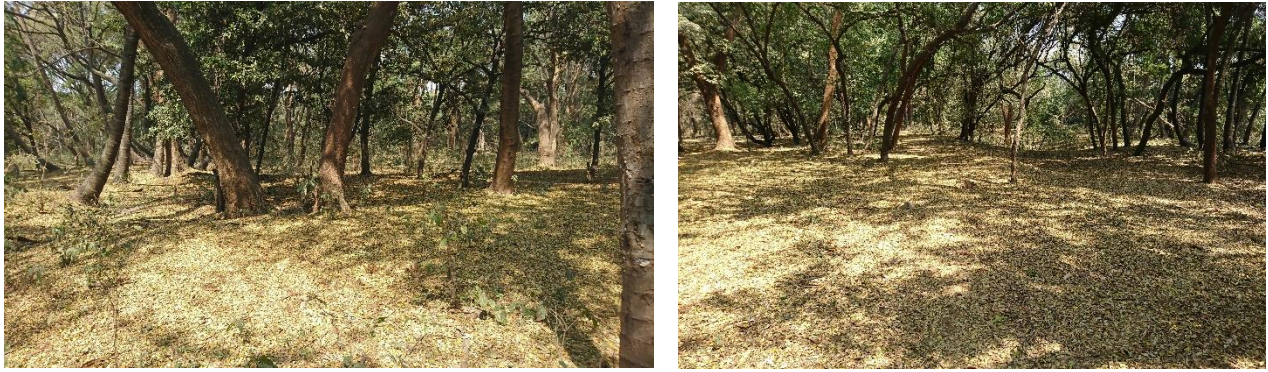
Already existing trails were noticed with trees, planted in a linear fashion on both sides. There is diversity in 'plantation', leading to speculations the ownership status of these river islands. Prominent vegetation includes:

Fig 18 (above): The variety of vegetation on the island along the naturally existing trail.  
 Fig 19 (below): Vegetation mapping of the Island via Google Earth.

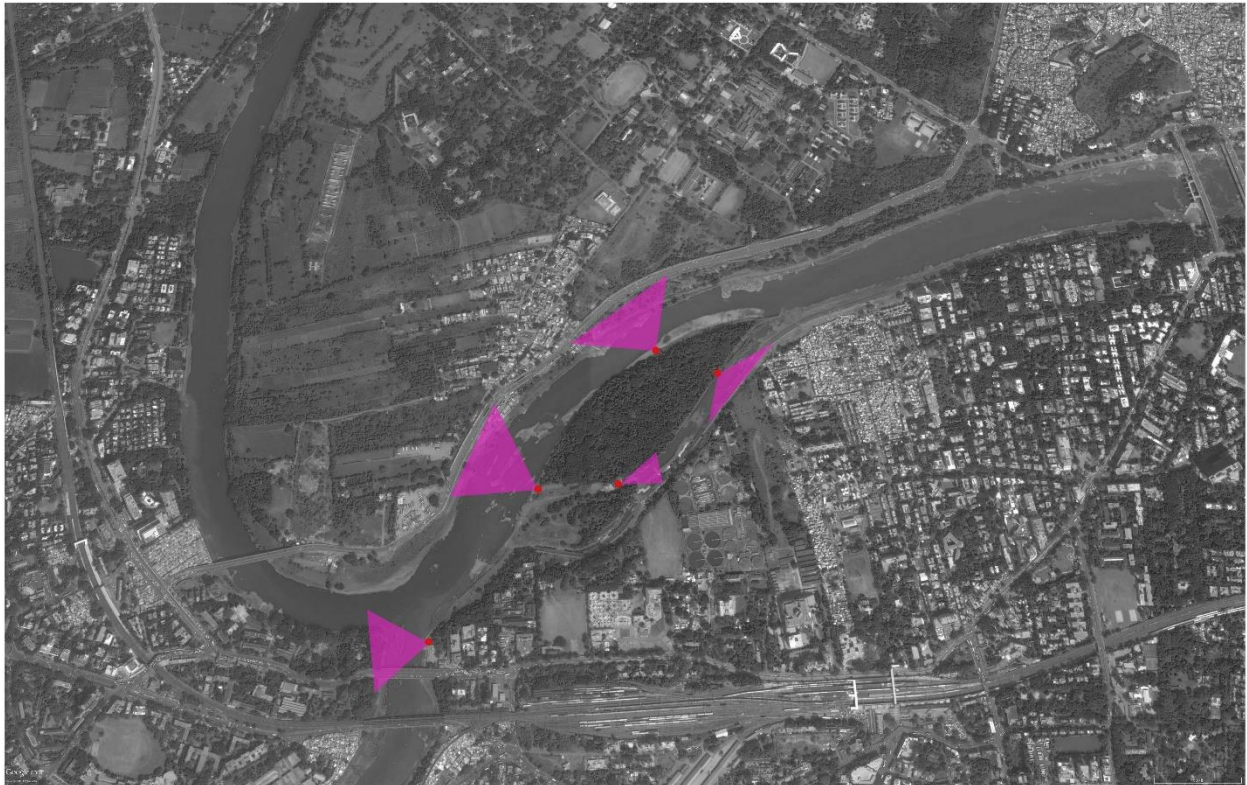
Fig 26: An overview of the Viewsheds around the site edges.

**THE GHAT:** The religious complex is 2 storeys (approx. 6-7 mts.) lower than than the main road. It houses a temple, a Ganpati Visarjan pool, public convenience facilities and a large congregational space adorned by 2 beautiful mature trees (figs.2 & 3).

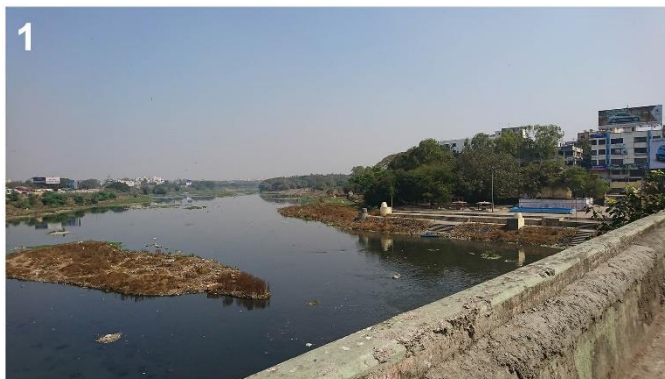
Fig 26.1: The river island on the far side with the Ghat in immediate view; as visible from the Sangamwadi Bridge.

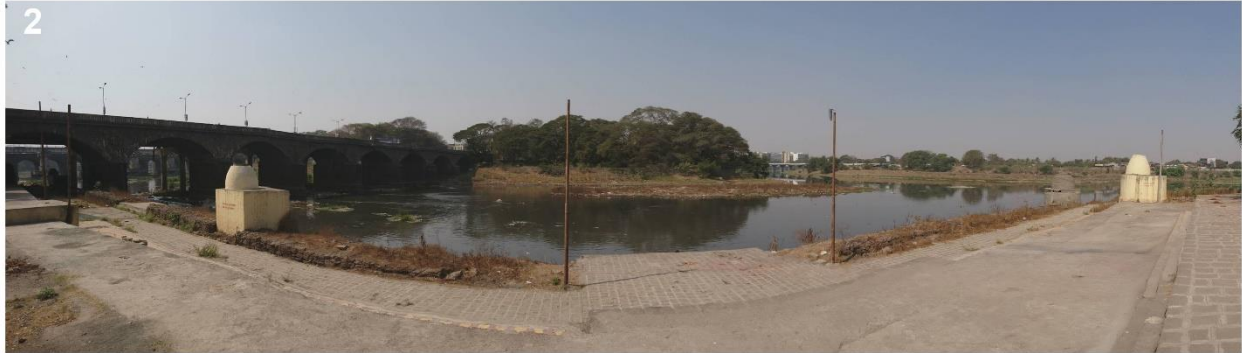
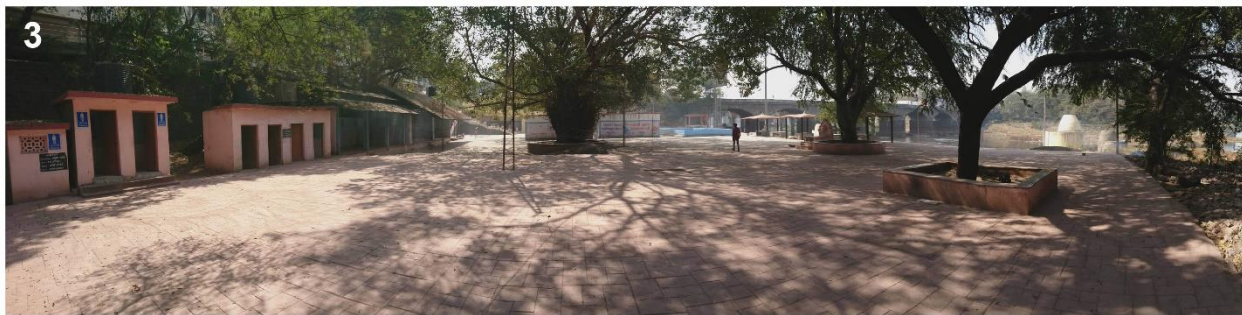
Fig 26.2 & 26.3: The Ghat, which is situated at the junction where the rivers meet, is mostly used during Ganpati Puja and is a backdoor entry for the trail to the island.

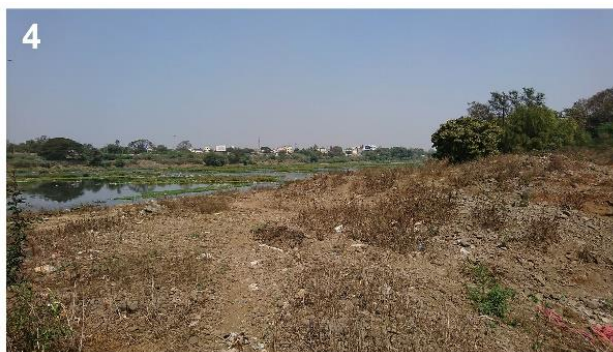
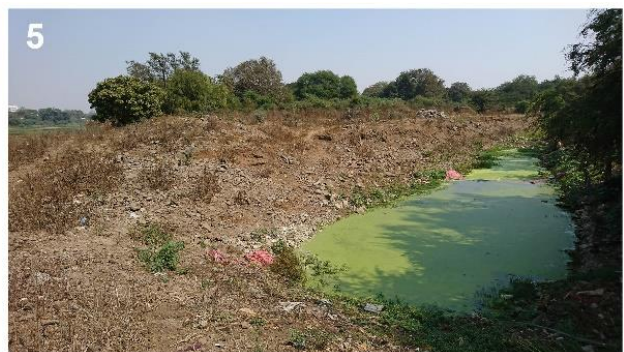
THE SITE: The present access to the river islands is through a crematorium. As we move towards the junction where the 2 islands meet, we notice an algae bloom and garbage littered river bank. The litter is suggestive of the fact that it is deposited when the river flow is substantial during peak monsoons (figs.4 & 5).

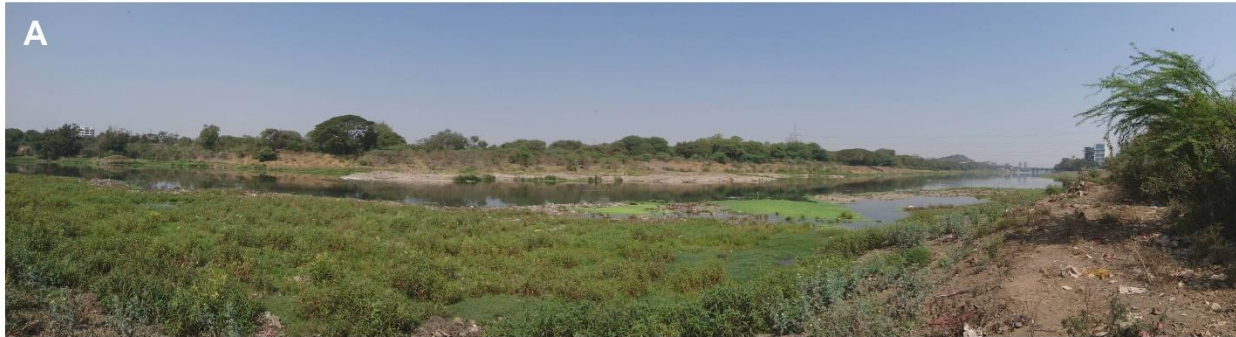
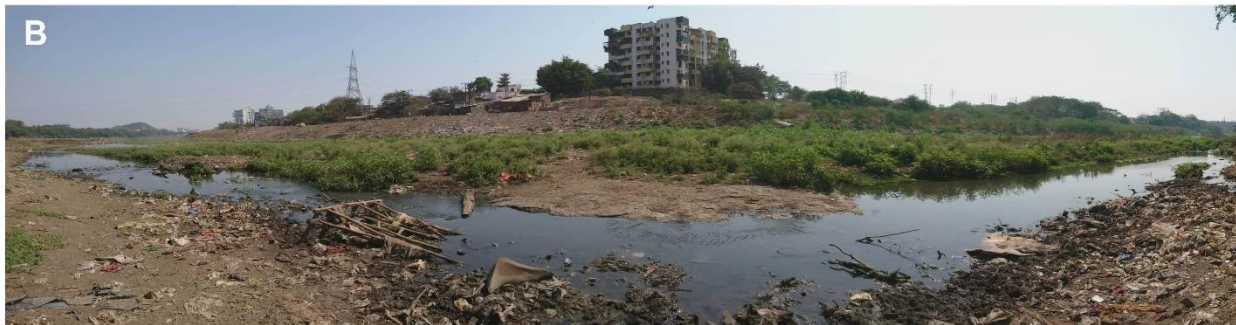
THE EDGES: The island edges are littered with debris and garbage disposed of from regions upstream and small pockets of slum dwellers. There are small deposited sediment beds of water tolerant plants as well as water hyacinths over the water surface. Also proximity of the settlements (as seen in fig.B) from the river edges seem to play a major role in garbage disposal.

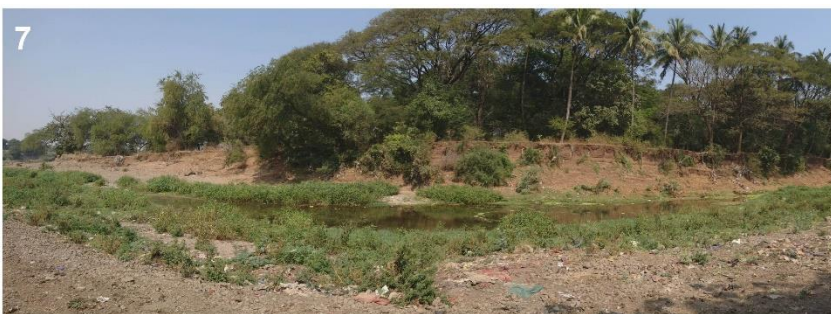
As one moves through the site, extensive erosion is noticed on the island junction (fig.7). A unique palette of vegetation on the island noticed and the transition from deciduous to riparian happens over a short distance (fig.8 & 9). The 'treated' water released from the sewage treatment plant (fig.10).

Fig 26.8, 26.9 & 26.10: The causes of degradation of the site is not only through man-made means, nature too has taken a toll.

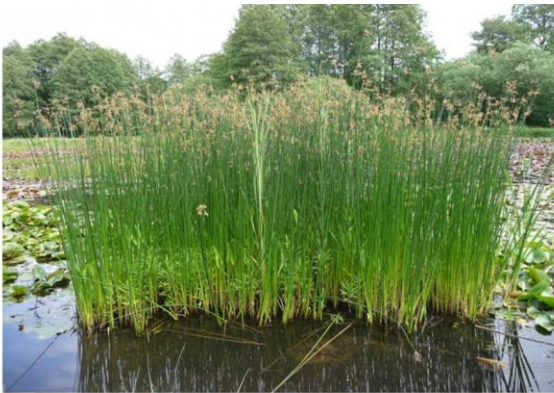
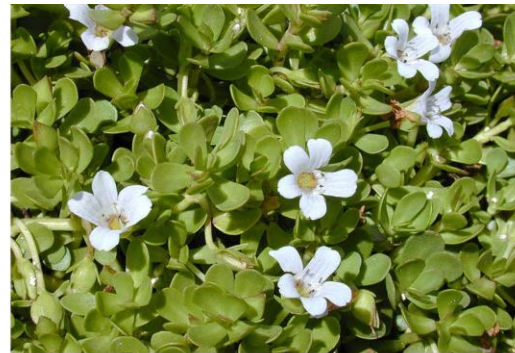
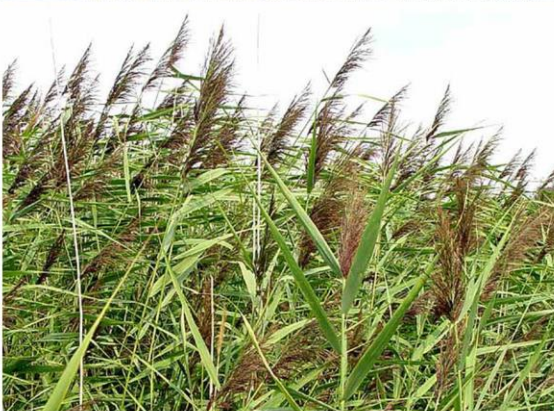
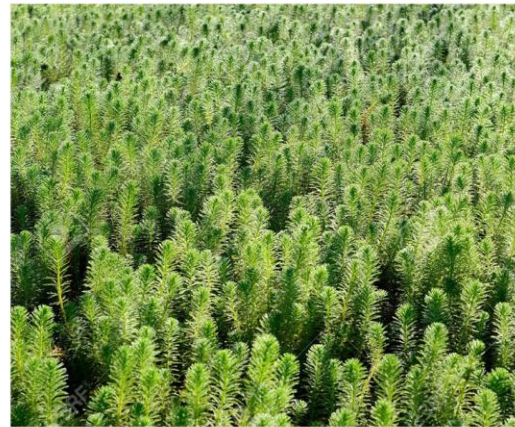
In India, aquatic vascular plants like *Hydrilla verticillata*, *Spirodela polyrrhiza*, *Bacopa monnieri*, *Phragmites karka* and *Scirpus lacustris* can be planted along the river edges effectively to absorb unwanted dissolved organic as well as industrial effluents in the water. Along with proper planting & soil binding techniques, such vegetation can help in improving the water quality.

Fig 29: (From Left) Species for Phytoremediation Bed  
*Scirpus lacustris*, *Bacopa monnieri*, *phragmites karka*, *Hydrilla verticillata*.

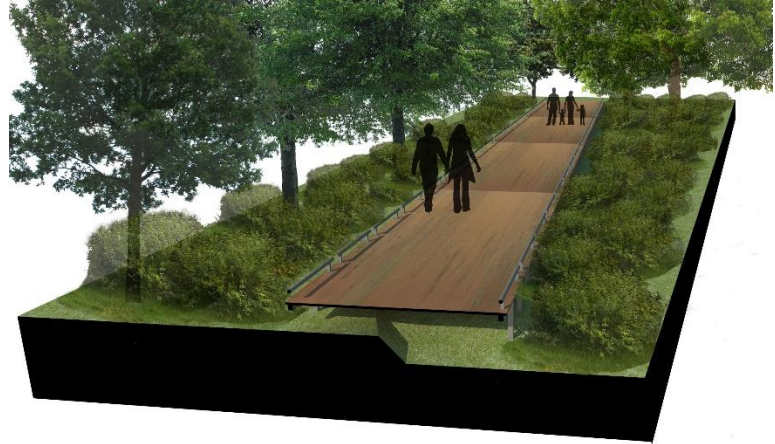
Fig 29: Boardwalks, an ideal solution to roam in a 'forest' without disturbing the surrounding land.

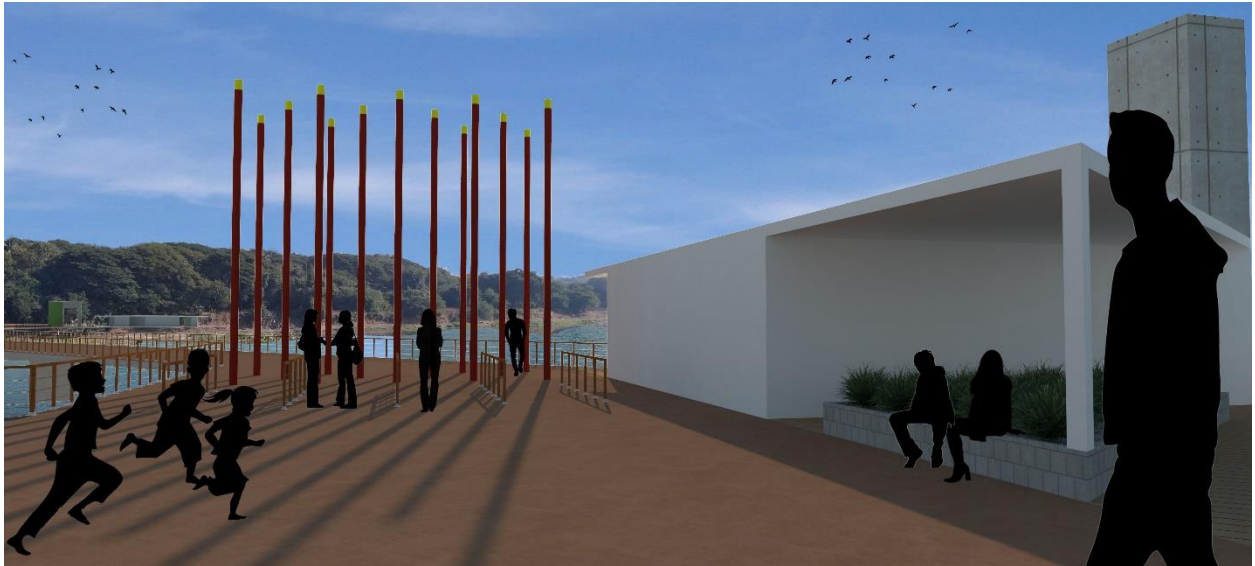
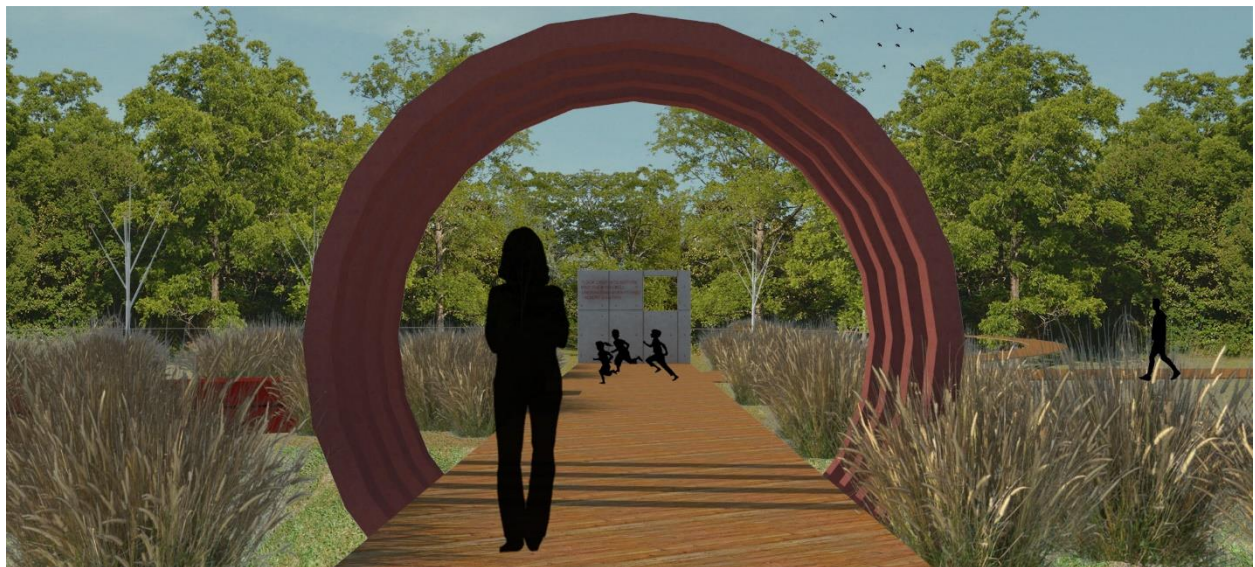
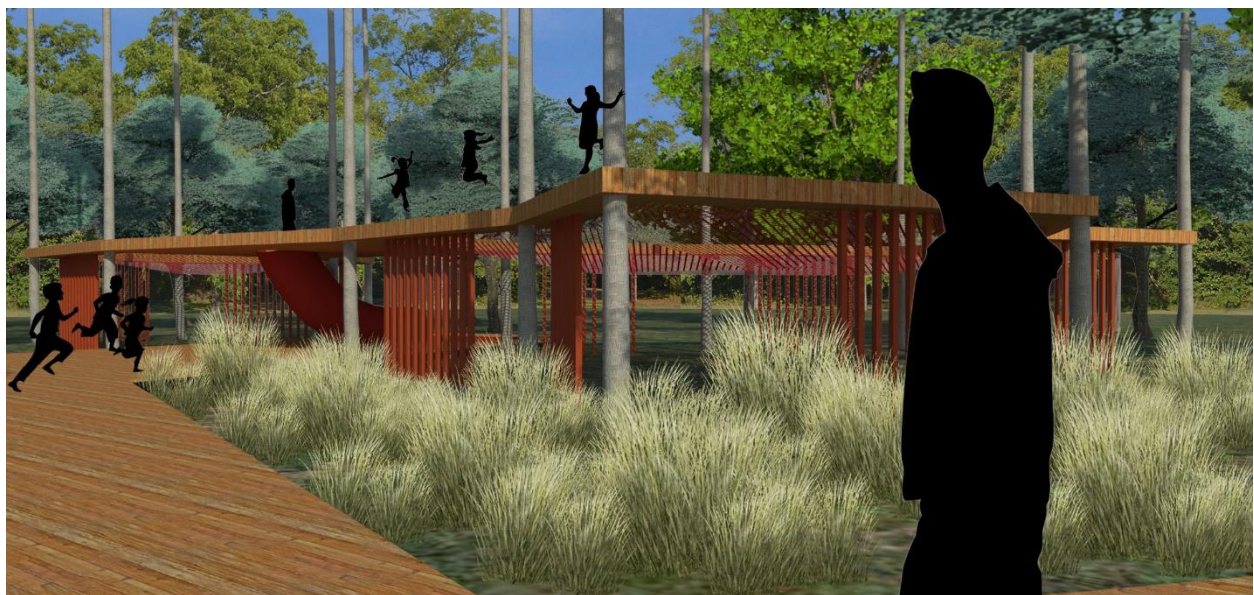
Fig 30: Isometric Blow-up of the evolution of the circulation pattern on the site.

The elements and spaces are designed keeping in mind that the site is sensitive to human interference and this interaction with the nature is to be kept to a minimum. Hence the visitors are made to travel through the site on elevated boardwalks. These boardwalks make the visitors experience the available interplay of the vistas offered by the site by travelling through a network of open spaces.
